# **Urban Wildlands Fire Pebble Beach, California (May 31, 1987)**

**Investigated by: Hugh W. Graham**

**This is Report 007 of the Major Fires Investigation Project conducted by TriData Corporation under contract EMW-86-C-2277 to the United States Fire Administration, Federal Emergency Management Agency.**

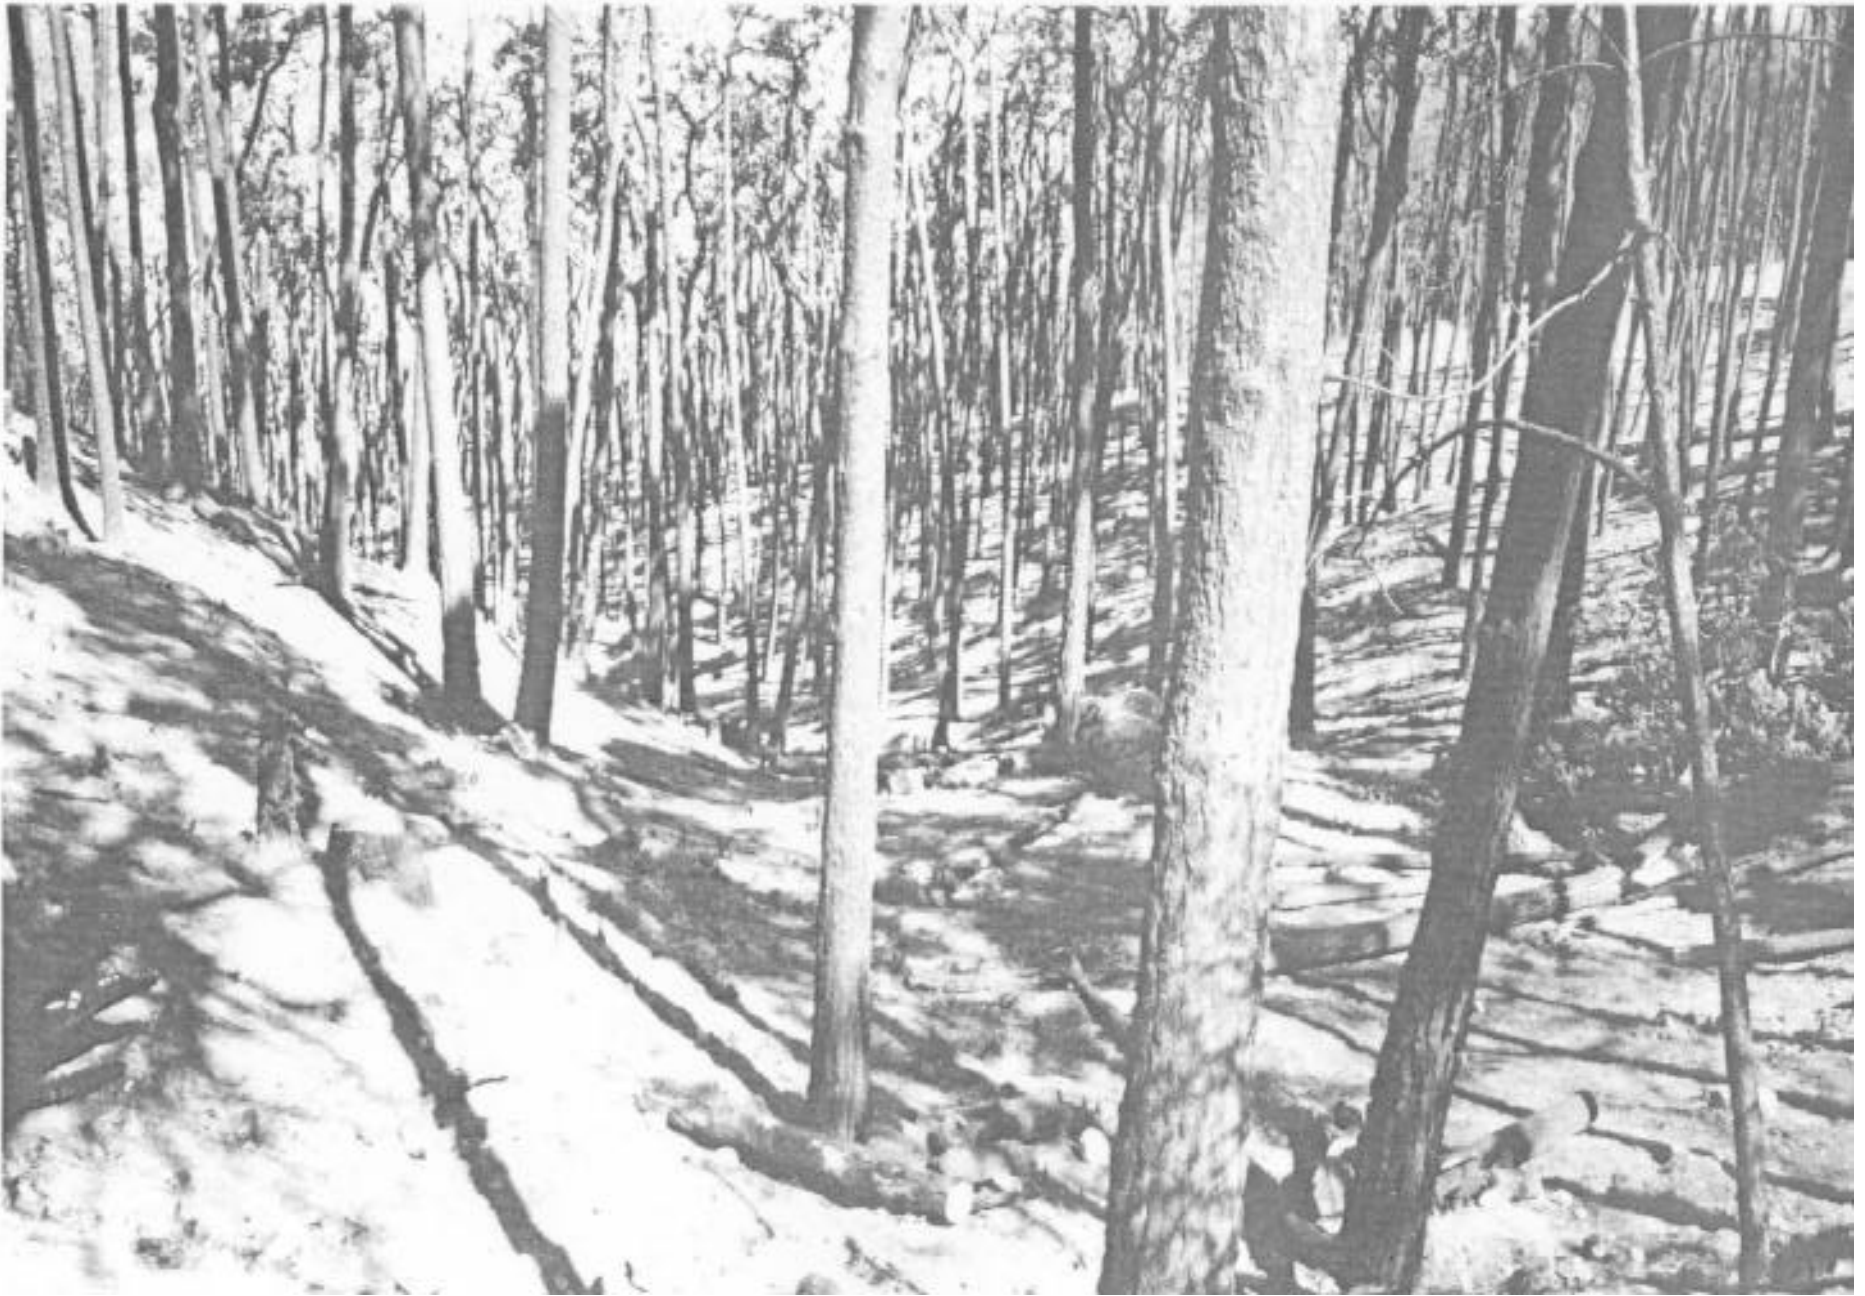
- \*R1x15 - A view looking west/southwest from Los Altos Drive down the canyon or chimney in front of 4011 Los Altos Drive. Notice the intensity of the fire indicated by the complete burning of all materials in the area. Drowning also occurred along this portion of the ridge.

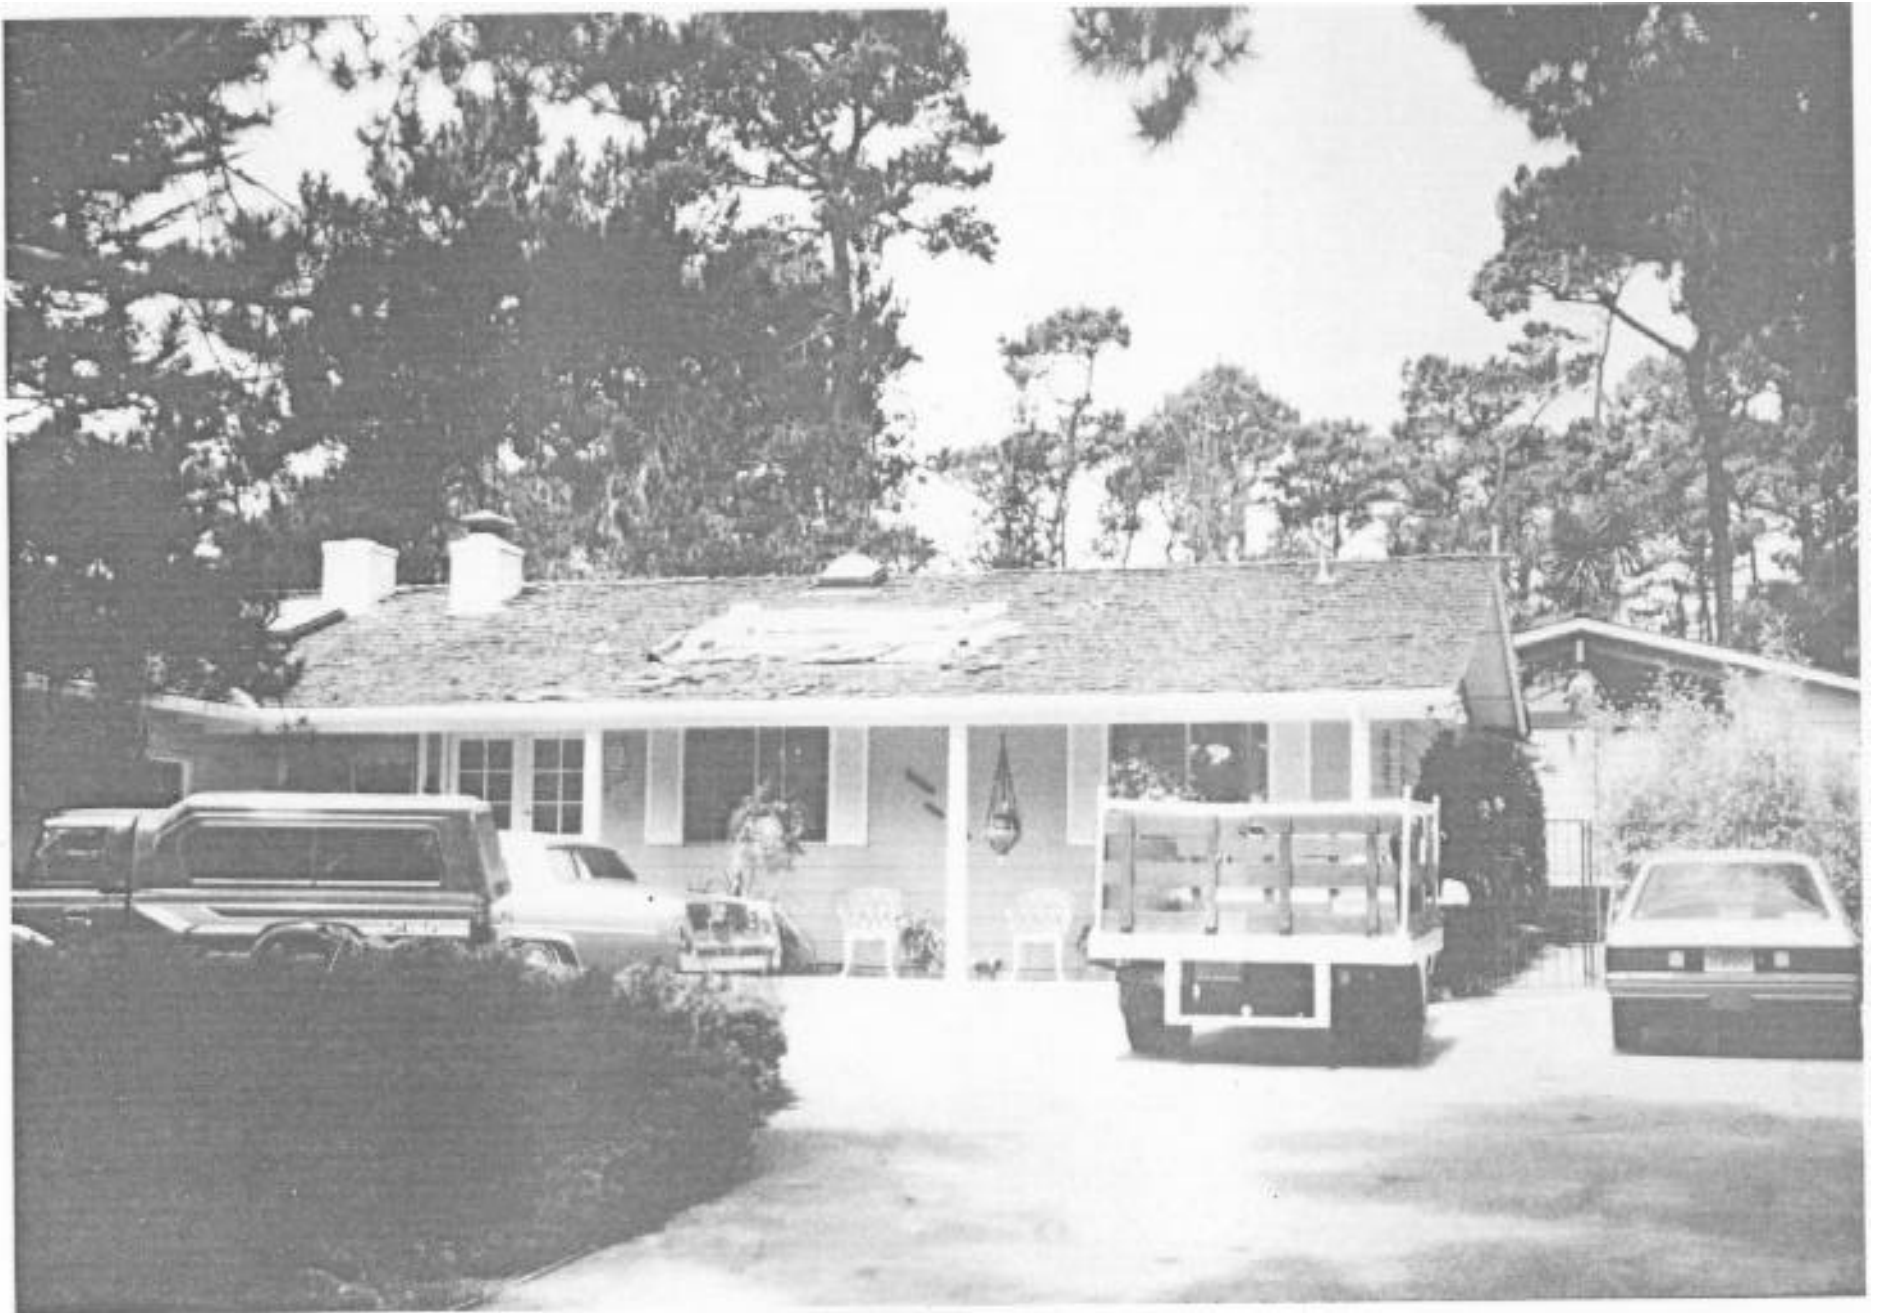
- \*R2x5 - A view of some of the typical spot damage to wood shingle or wood shake roofs around the area. Note the covering over an area where a hole has burned through the roof at this house.

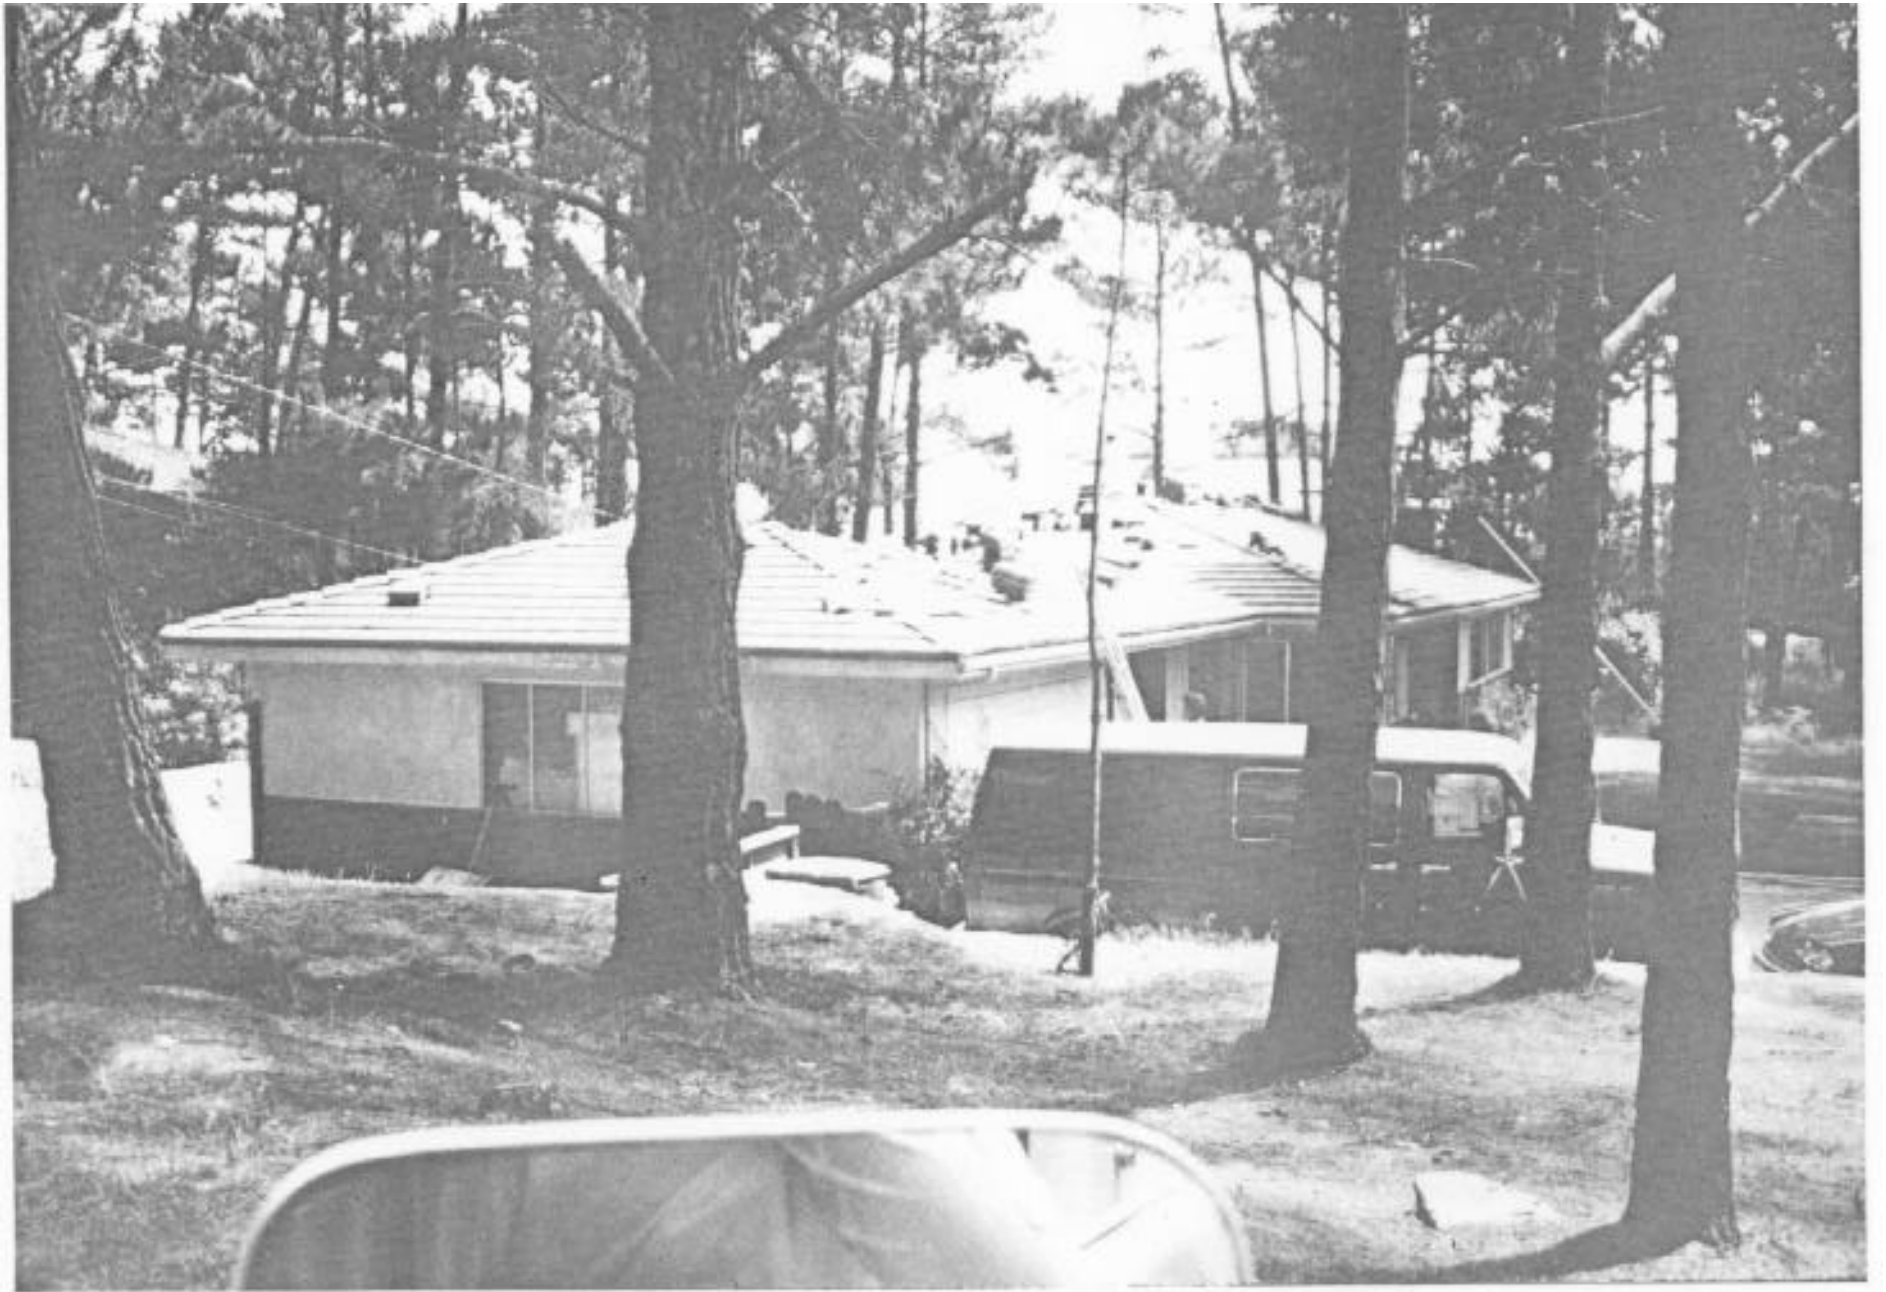
- \*R2x2 - An example of some of the aftermath of the fire. This house had minor roof damage and previously had a wood shingle roof. As can be seen, the house is now having the roof replaced with tile.
