Four Firefighters Killed, Trapped by Floor Collapse Brackenridge, Pennsylvania

**Four Firefighters Killed,
Trapped by Floor Collapse
Brackenridge, Pennsylvania
(December 20, 1991)**

**This is Report 061 of the Major Fires Investigation Project conducted
by TriData Corporation under contract EMW-90-C-3338 to the United
States Fire Administration, Federal Emergency Management Agency.**

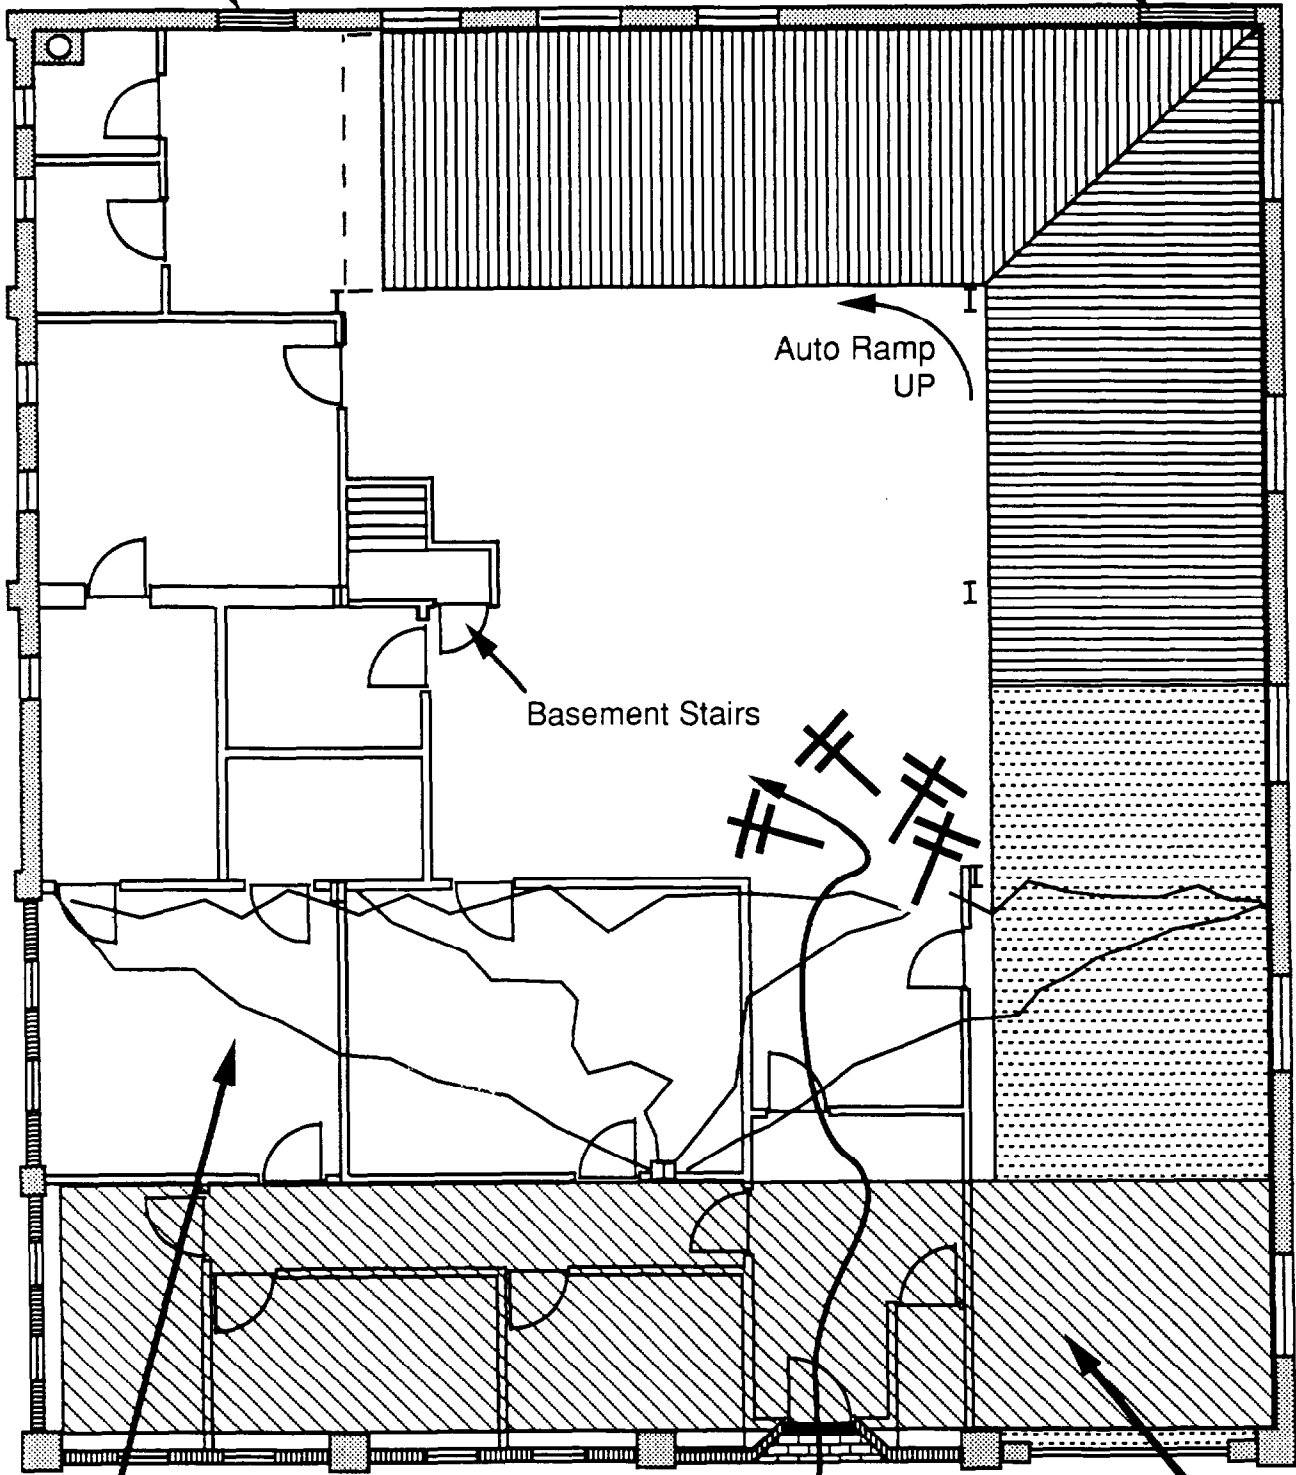
SECONDARY
COLLAPSE AREA

PRIMARY
COLLAPSE AREA

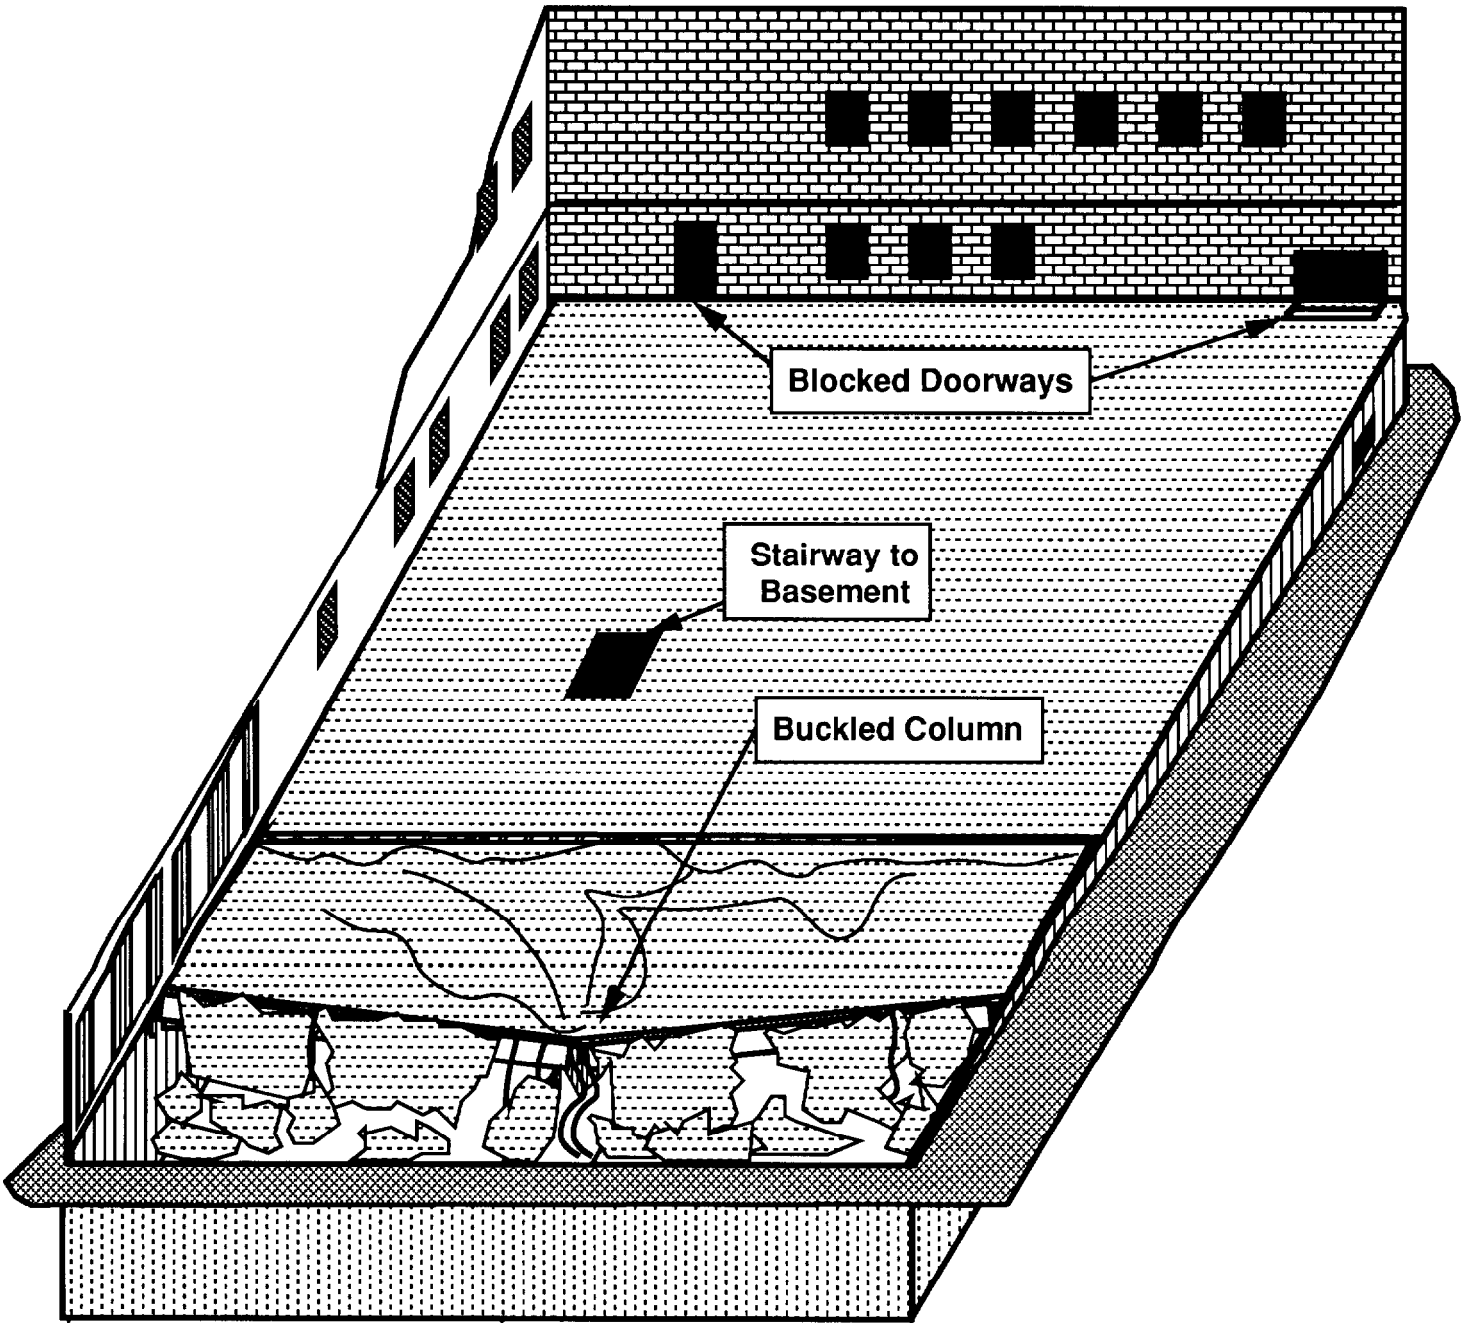
CUT-AWAY VIEW
Showing Floor Collapse

The primary structural collapse was caused by the failure of the steel joists supporting the floor slab above the finishing room. All of the joists between the front wall and the first set of support beams failed and dropped the concrete slab into the basement. Examination of the joists found in the rubble indicates that all were severely warped and twisted from heat exposure. The slab broke near the mid-point of the span and some sections were left hanging vertically from the beams. This created an

The middle column supporting the first set of beams was also buckled, although this appears to have been a secondary failure. The buckling of this column caused a secondary slab failure between the first and second sets of beams. The slab in the second bay sloped down toward the opening, with a low point at the center column, but did not drop into the basement. The remainder of the ground floor was not compromised.

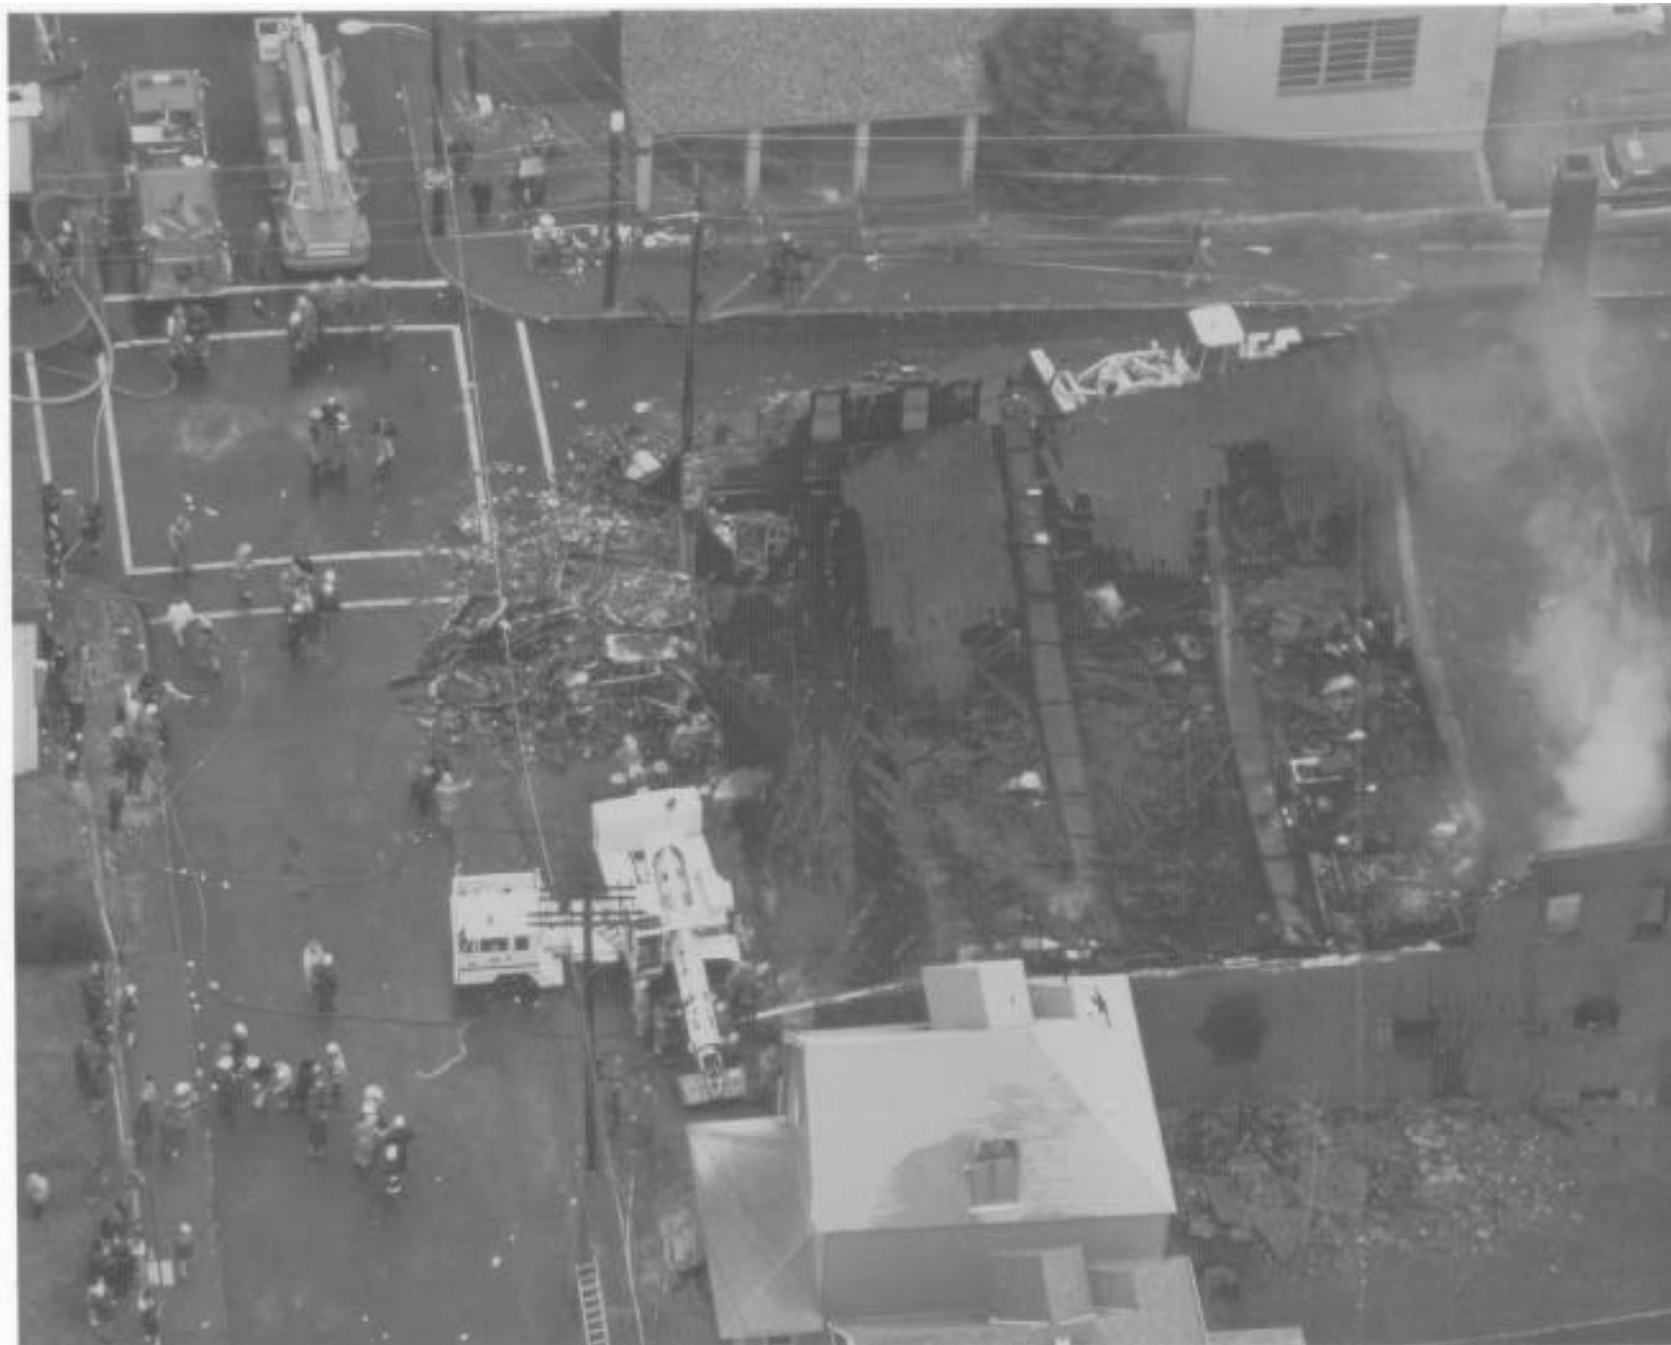
At the height of the fire; firefighters have pulled back.

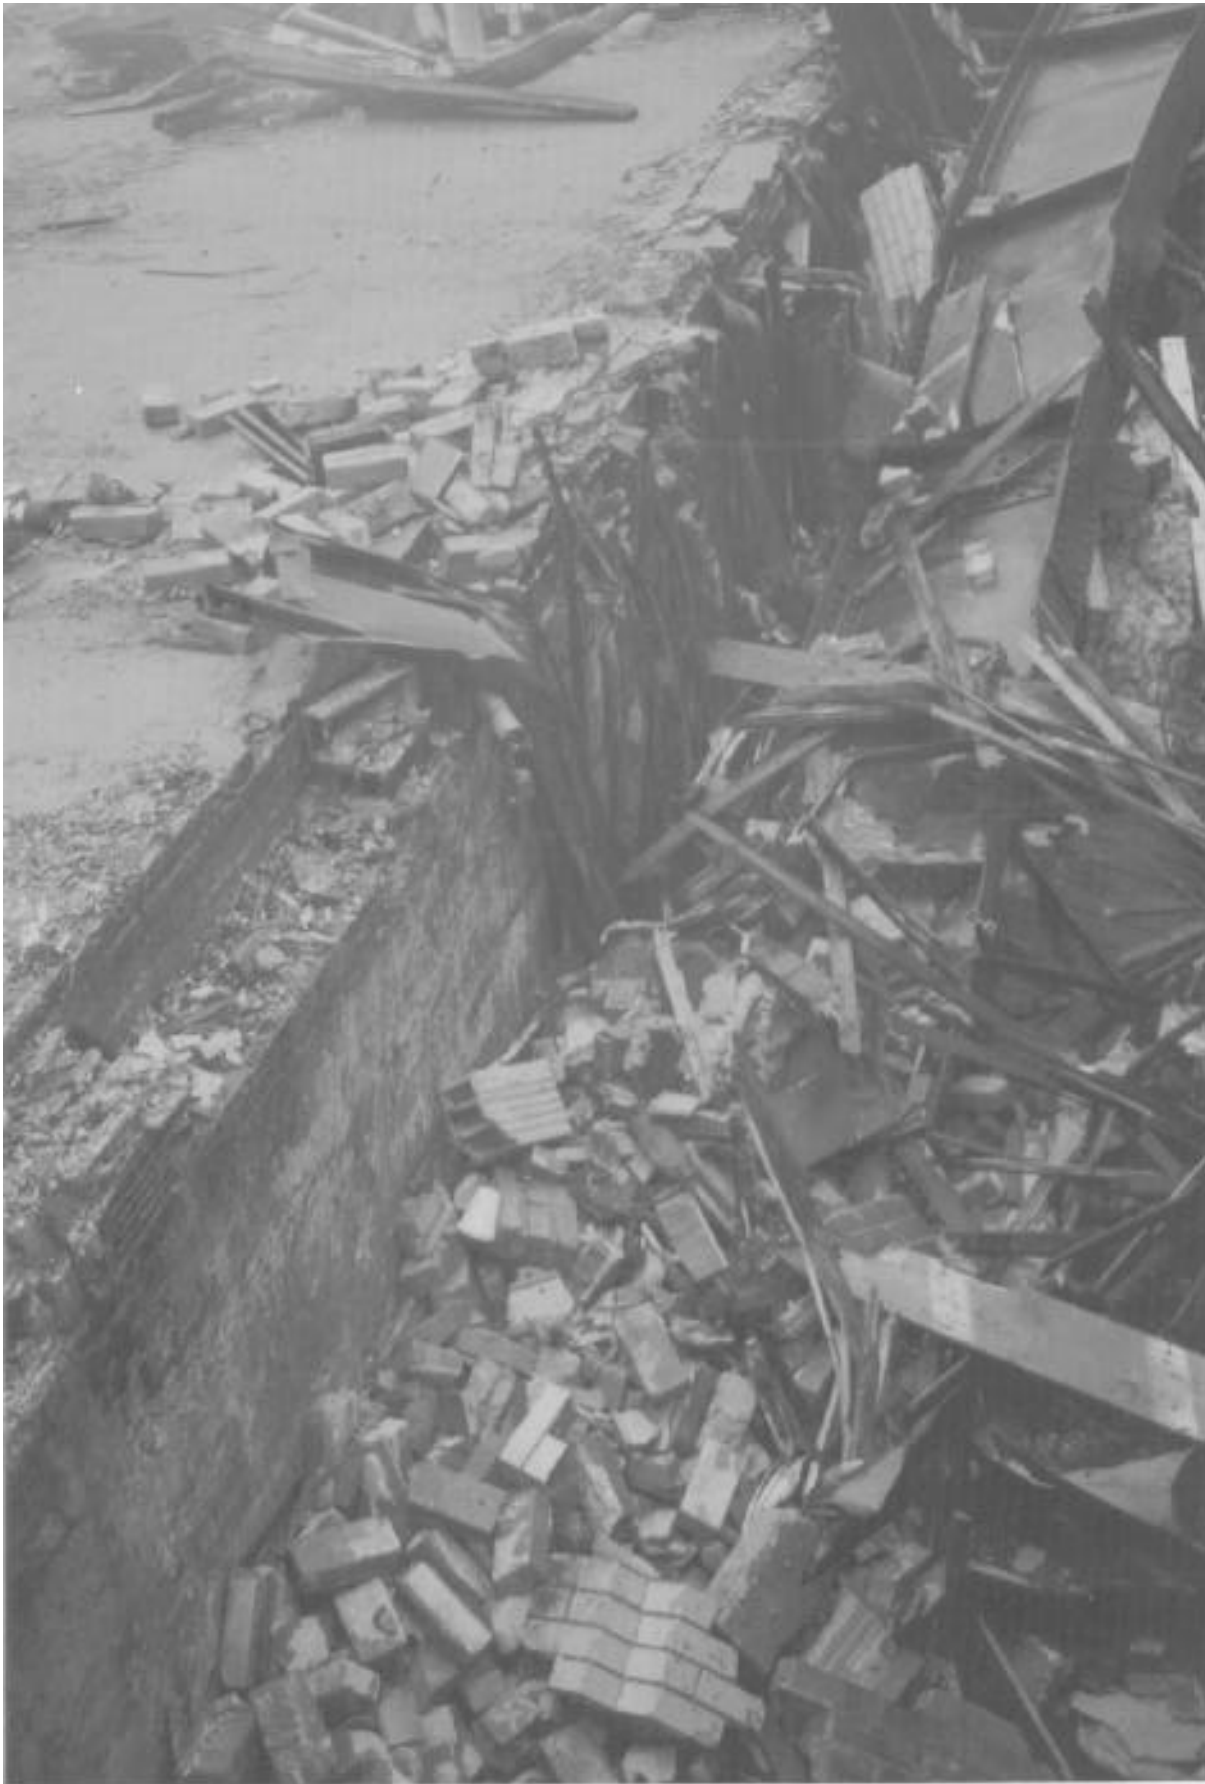
Looking toward Brackenridge Ave. from ground floor, near location where bodies were found. Debris in foreground is from first and second floors and from roof structure. Bent-over ends of floor joists are visible at the point of attachment to the basement wall.

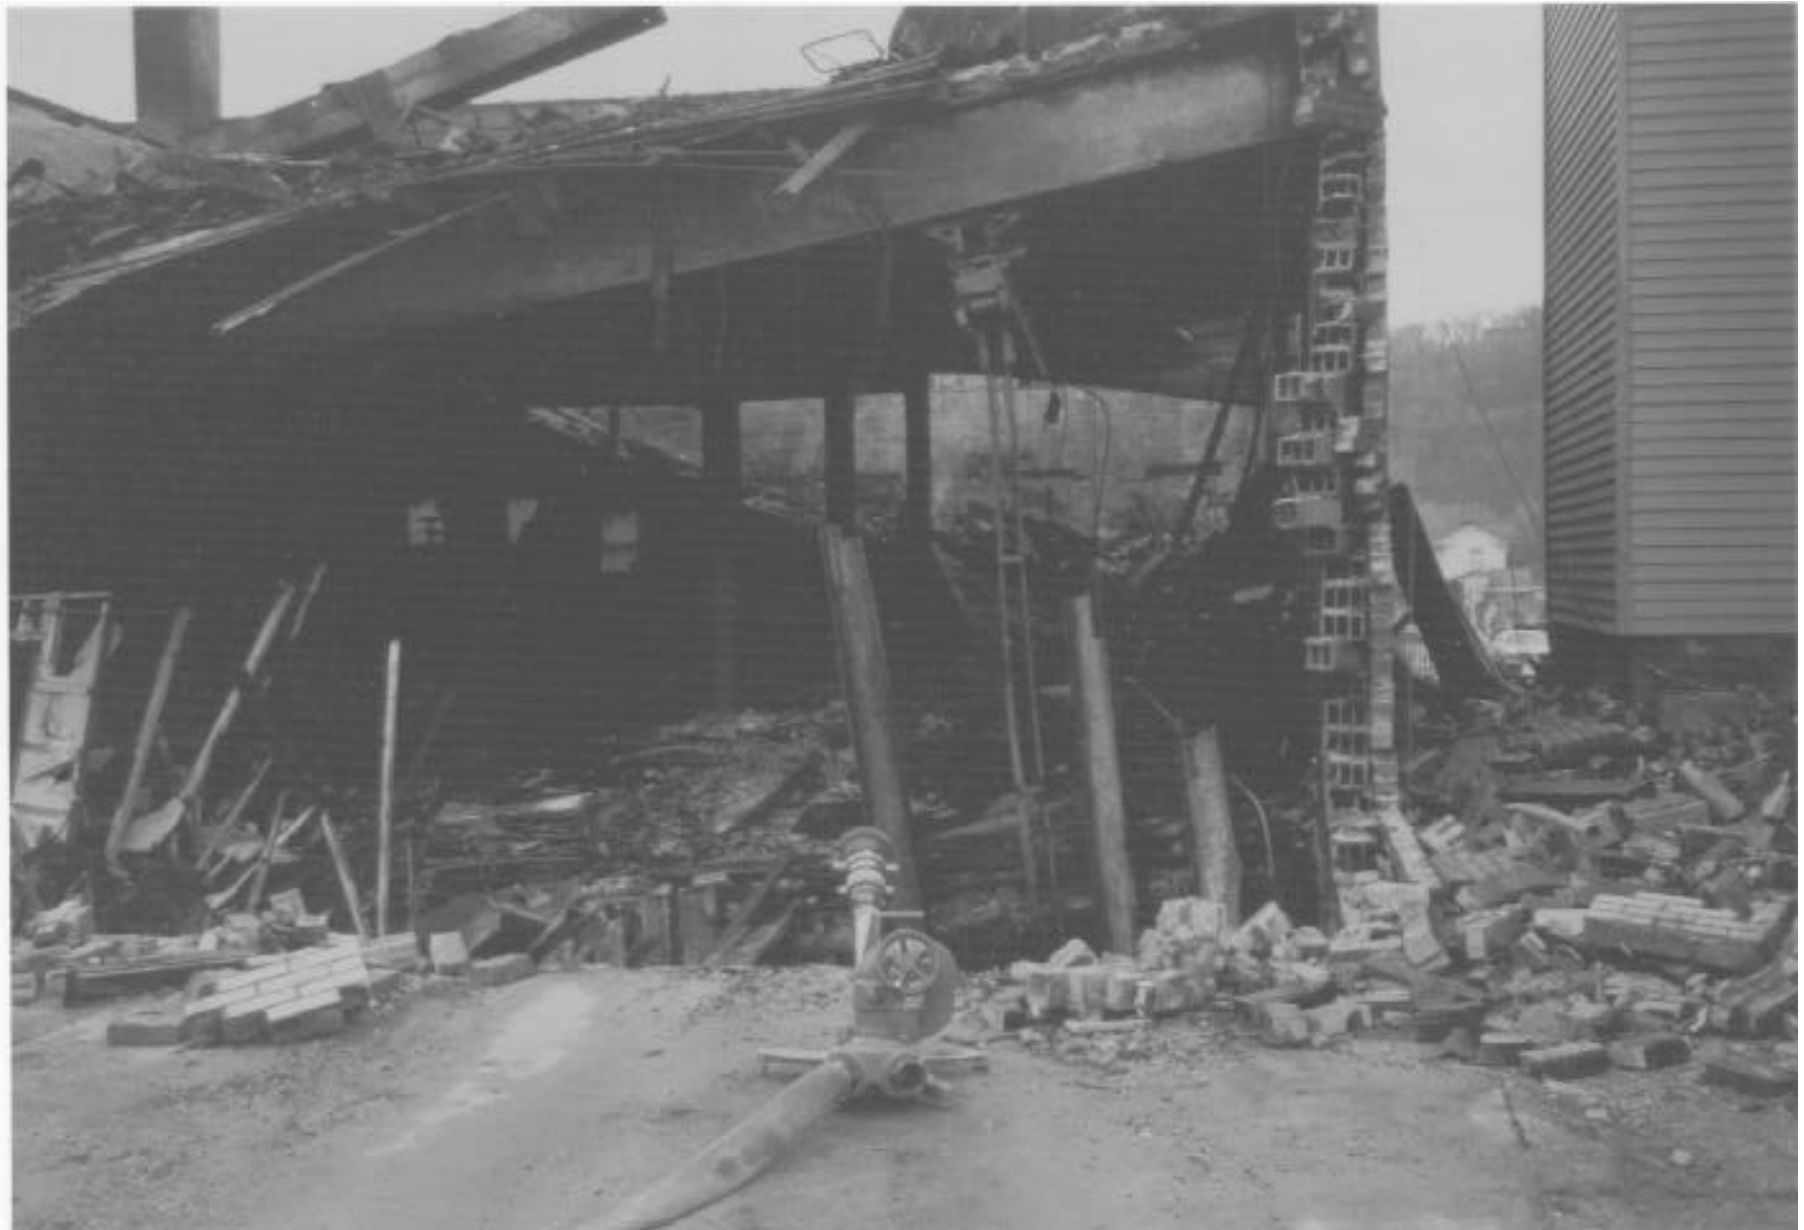
The individual joists were probably heated to the point of failure well before the collapse occurred; probably before the Fire Department arrived. They did not collapse immediately, because they were supported by the rigidity of the combined joist and slab assembly and the manner of support at the basement wall.

Point of rigid support for floor joists at front of building. Floor joists rested on concrete basement wall and were held in place by brickwork. (Steel girder is from roof structure.)

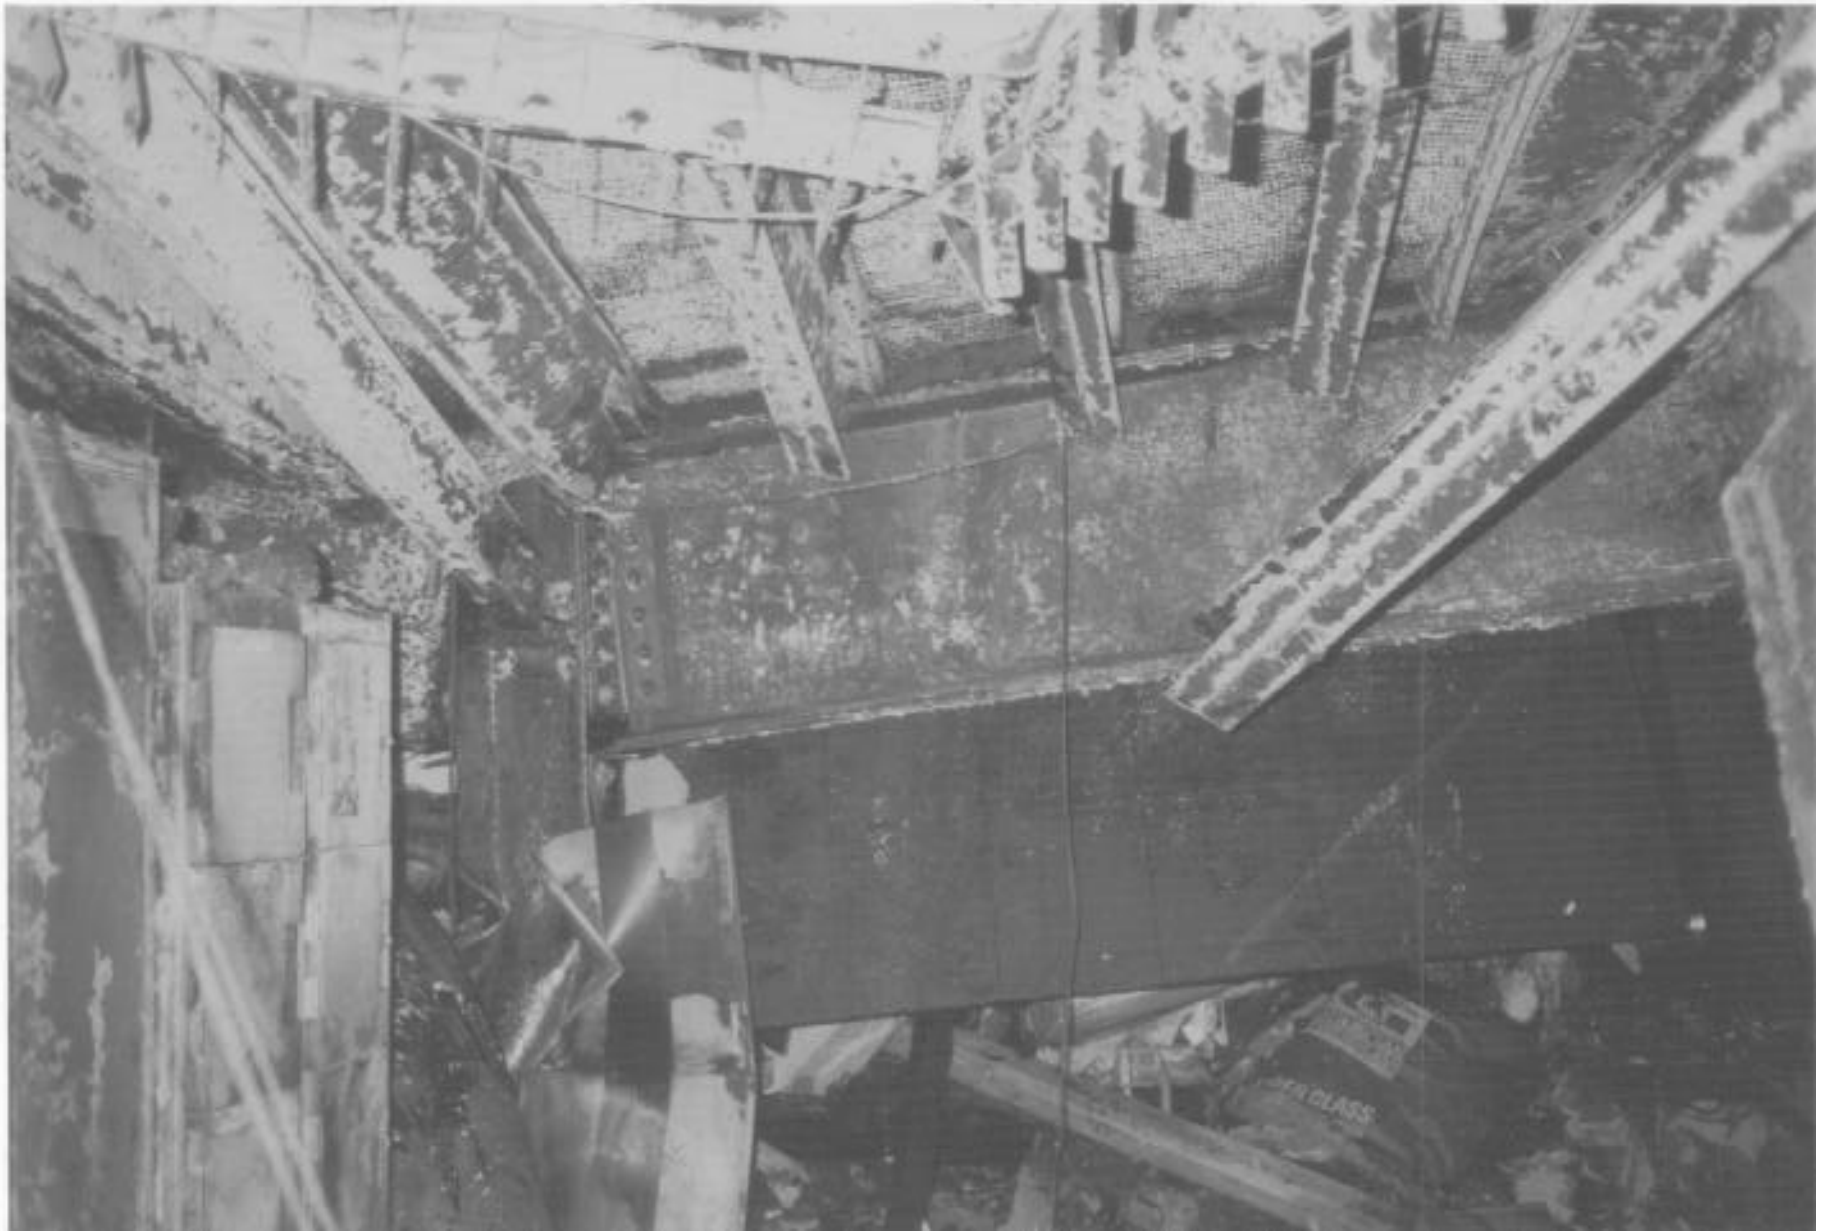
Partial view of exhaust duct for spray booth air discharges. Rear of metal spray booths and remnants of enclosure wall are visible.

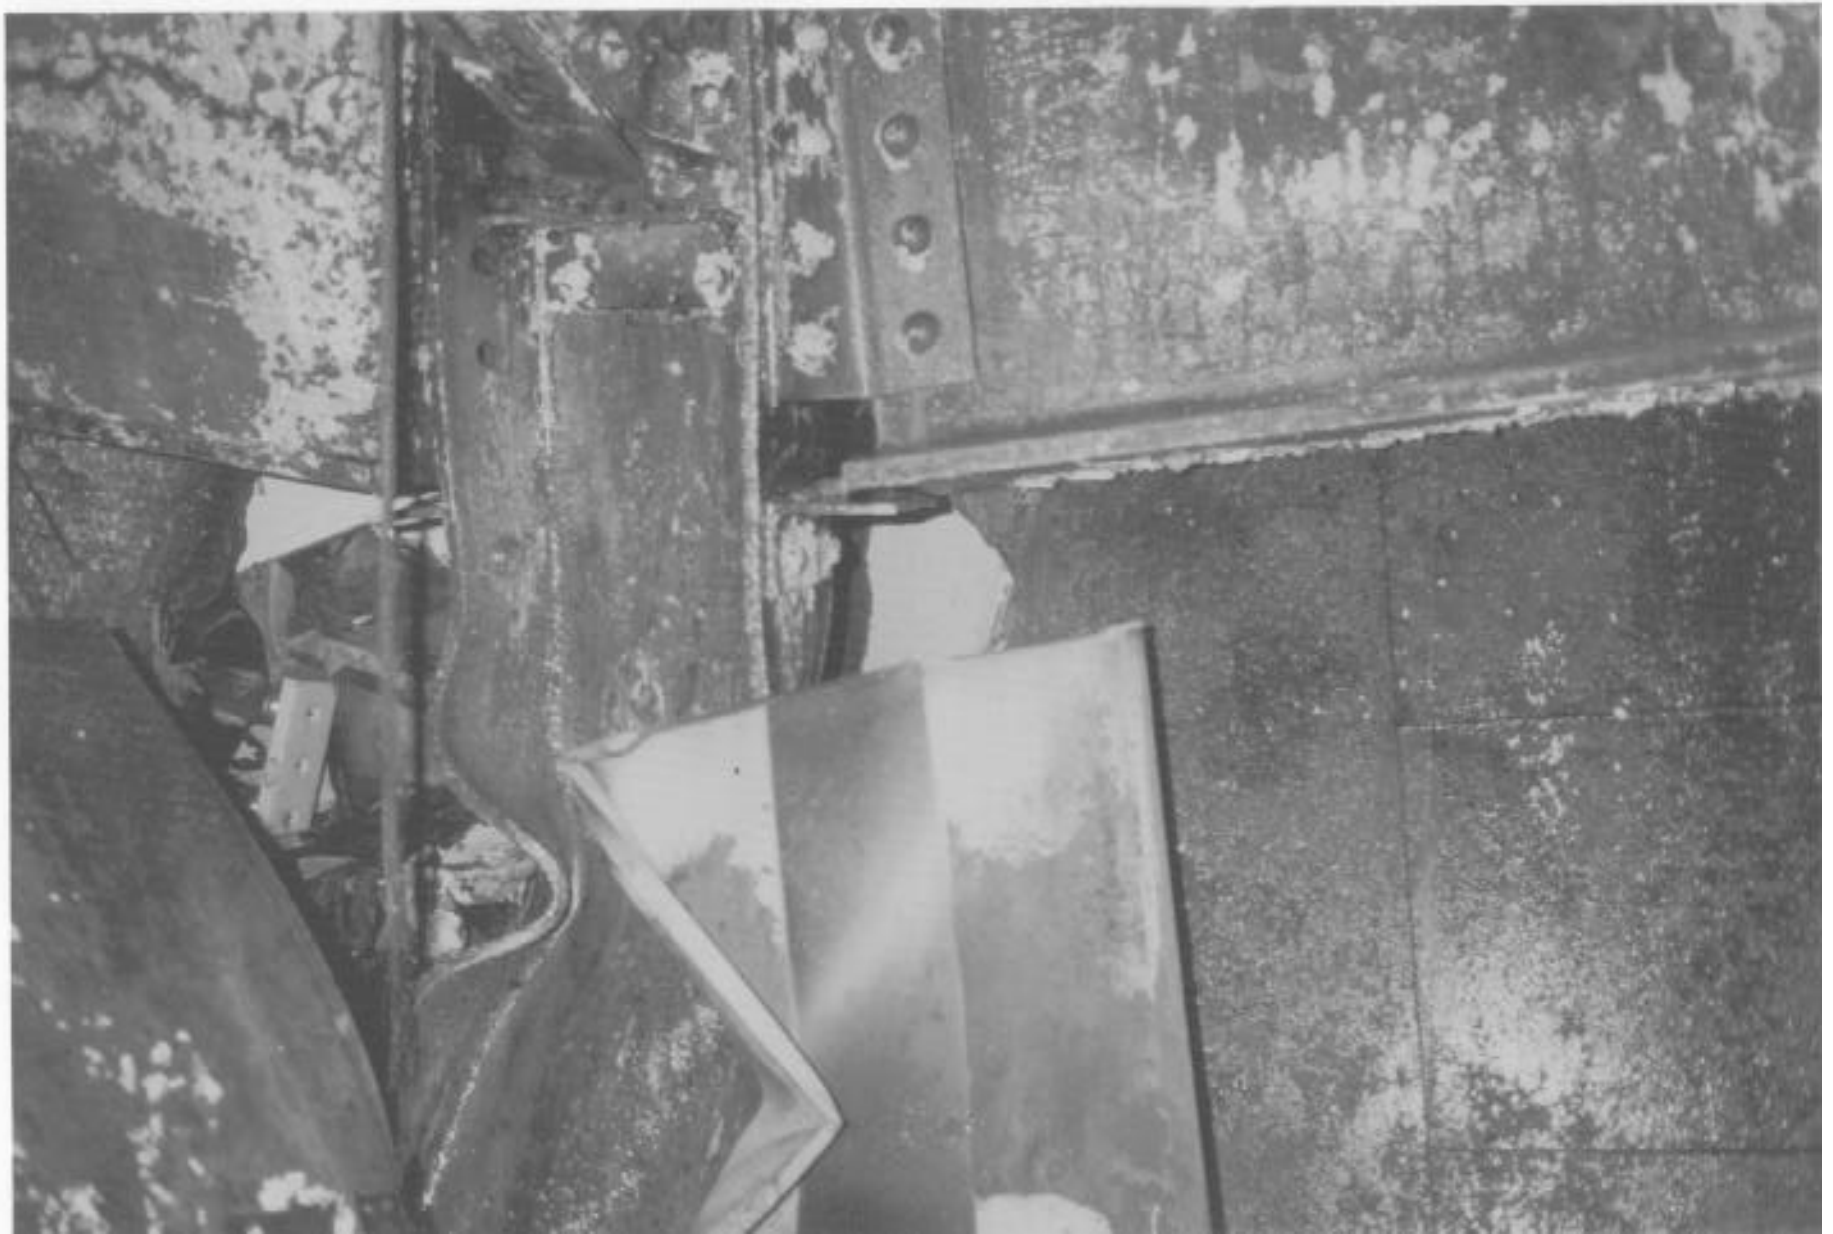
Connection between buckled center column and main beam. Note floor section hanging from opposite side of beam.

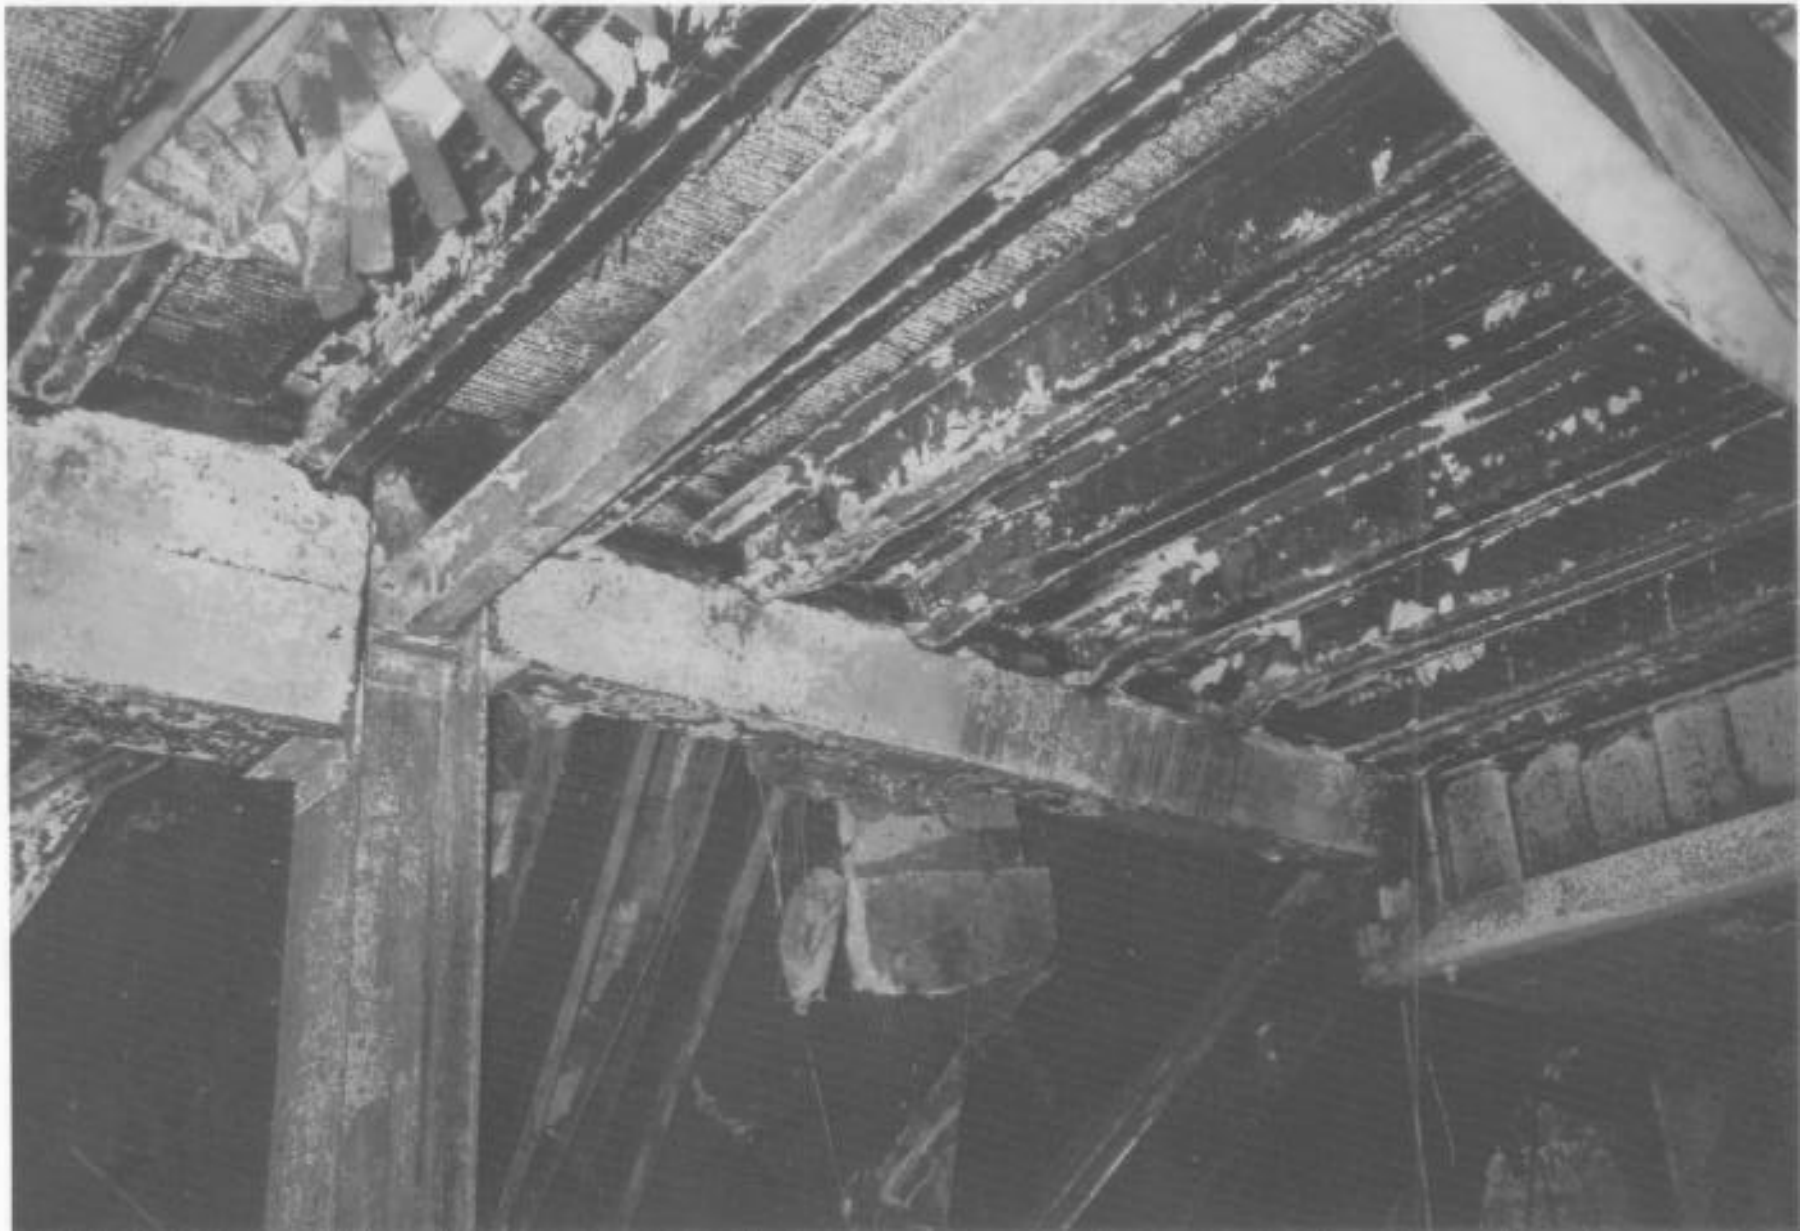
Detail of buckled center column, showing damaged connection of horizontal beam.

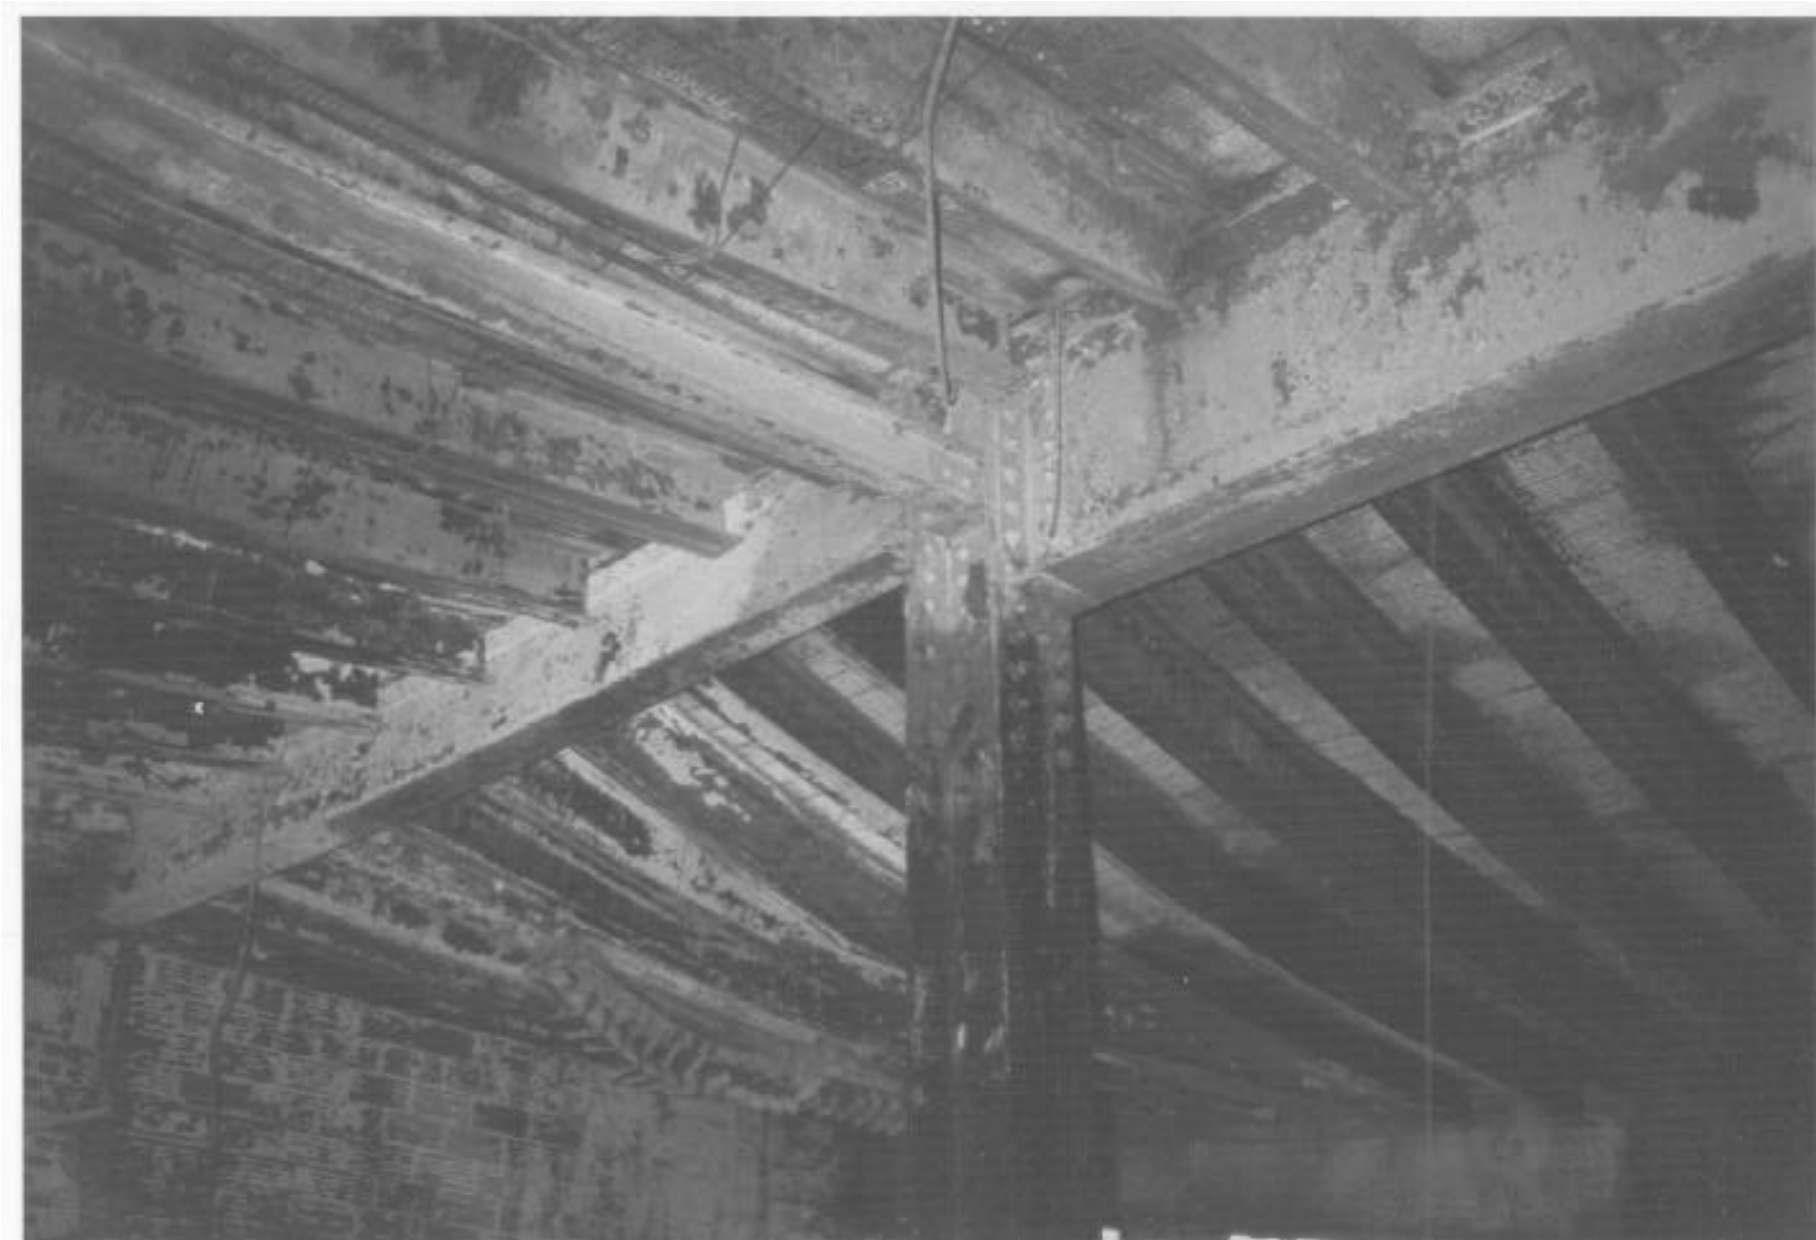
Basement steel beams, encased in concrete, on each side of unprotected column.

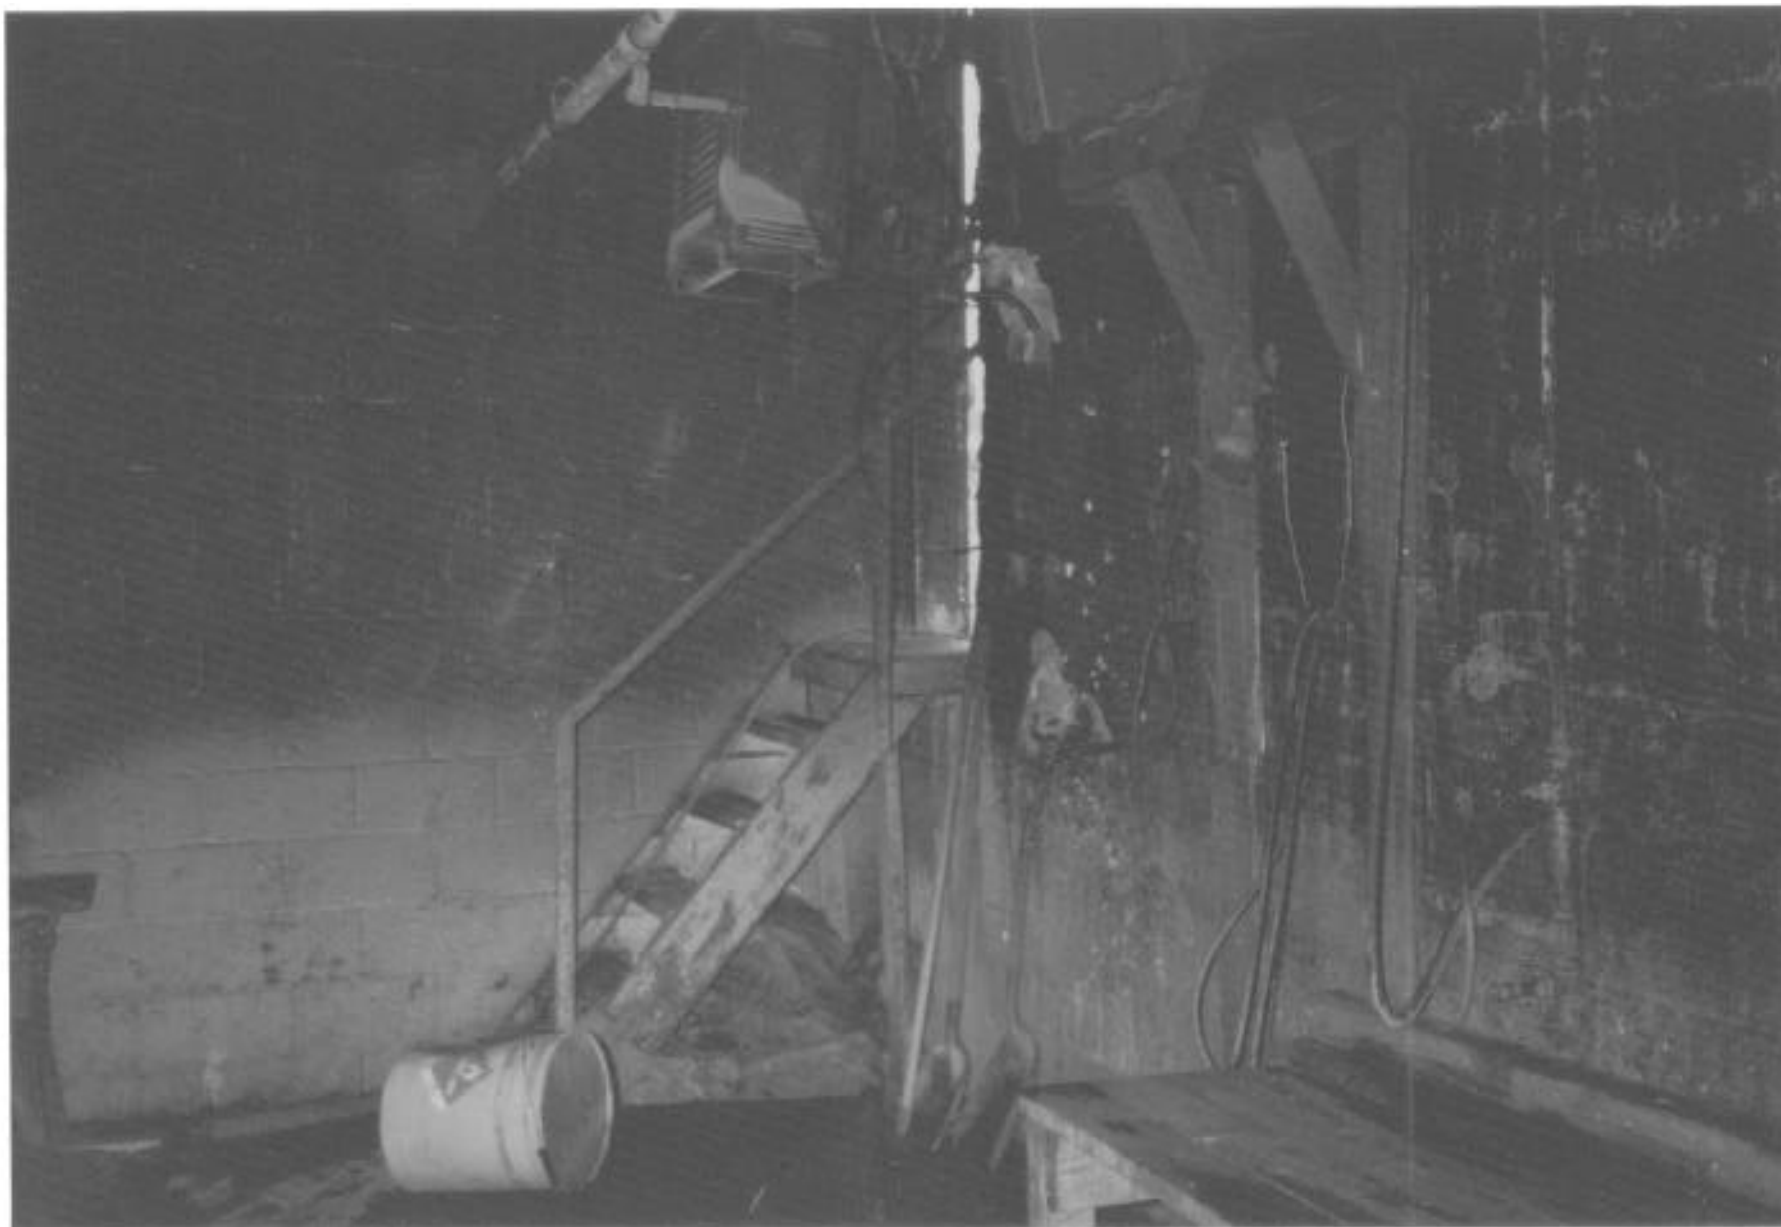
View of unprotected steel supporting second floor. Sag in joists resulted from exposure to the heat of the fire, although this area was not heavily involved in flames.
