## Manufacturing Mill Fire Methuen, Massachusetts

# **Manufacturing Mill Fire Methuen, Massachusetts**

# Manufacturing Mill Fire

December 11, 1995

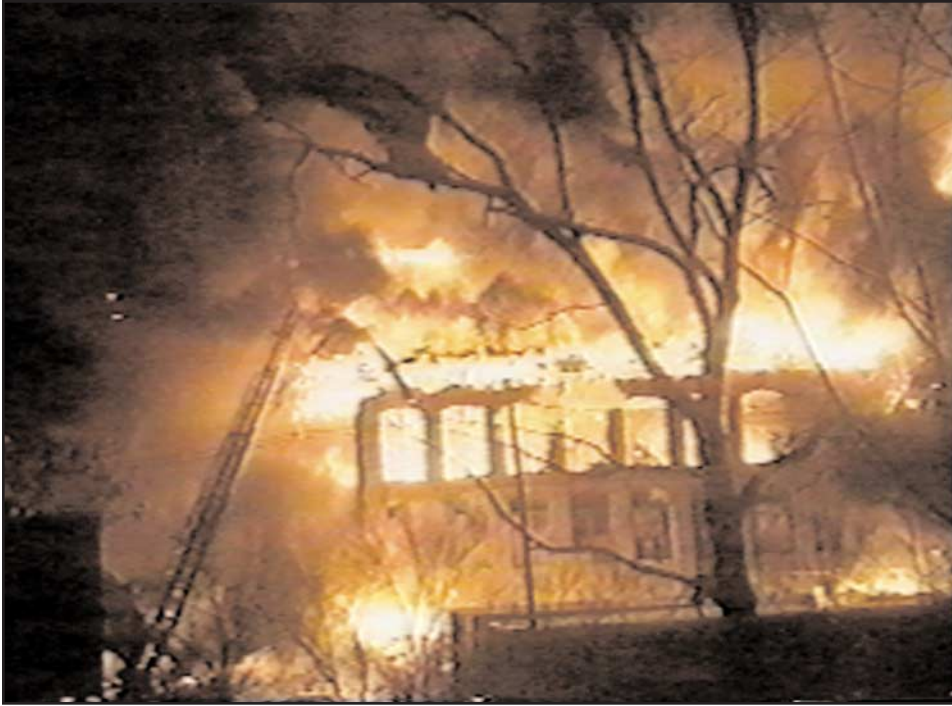
1. Ladder pipe operations near the northwest corner of the Monomac Building early in the fire. Vantage point was across the Spickett river.

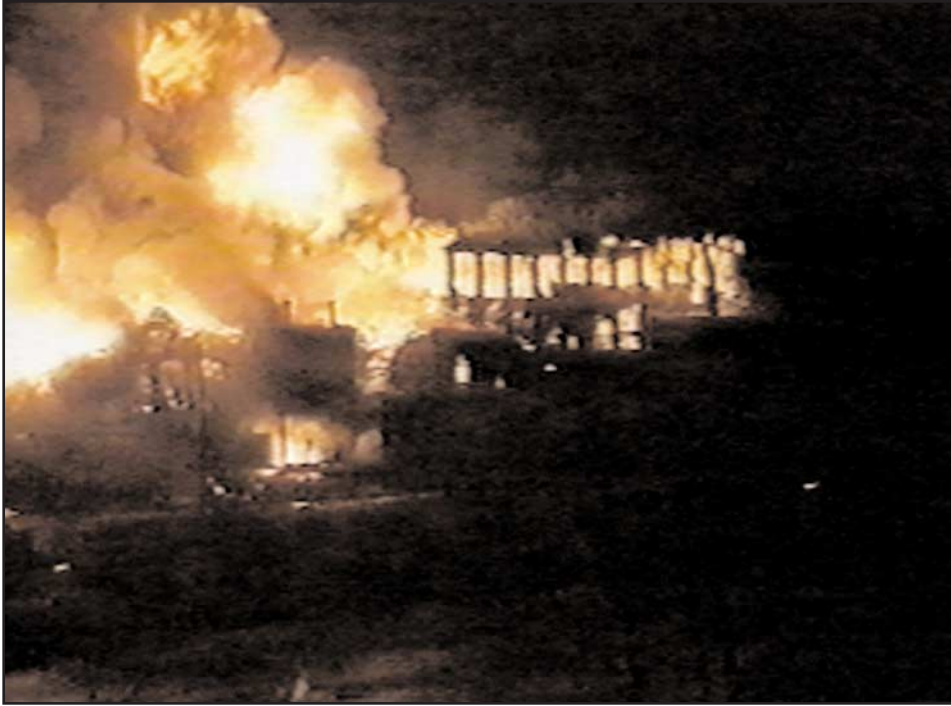
2. The fully involved west side of the Monomac Building; floors have collapsed as have some walls. Vantage point was across the Spickett River.

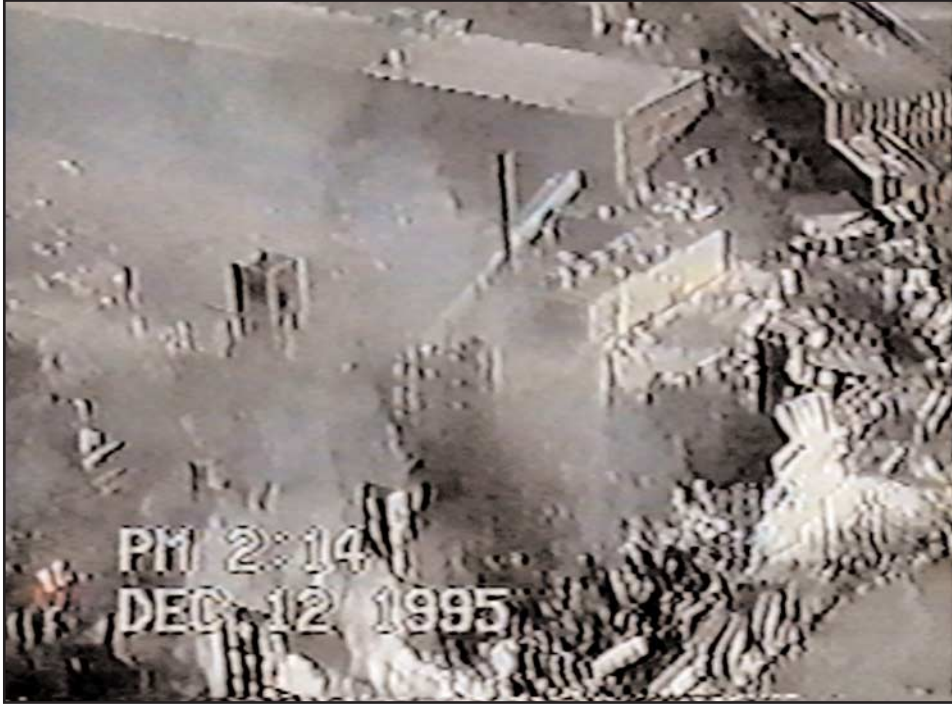
3. Ariel view of the fire scene early afternoon on December 12, 1995 looking southwest. The Mariner and Van Brodie Buildings are in the background.

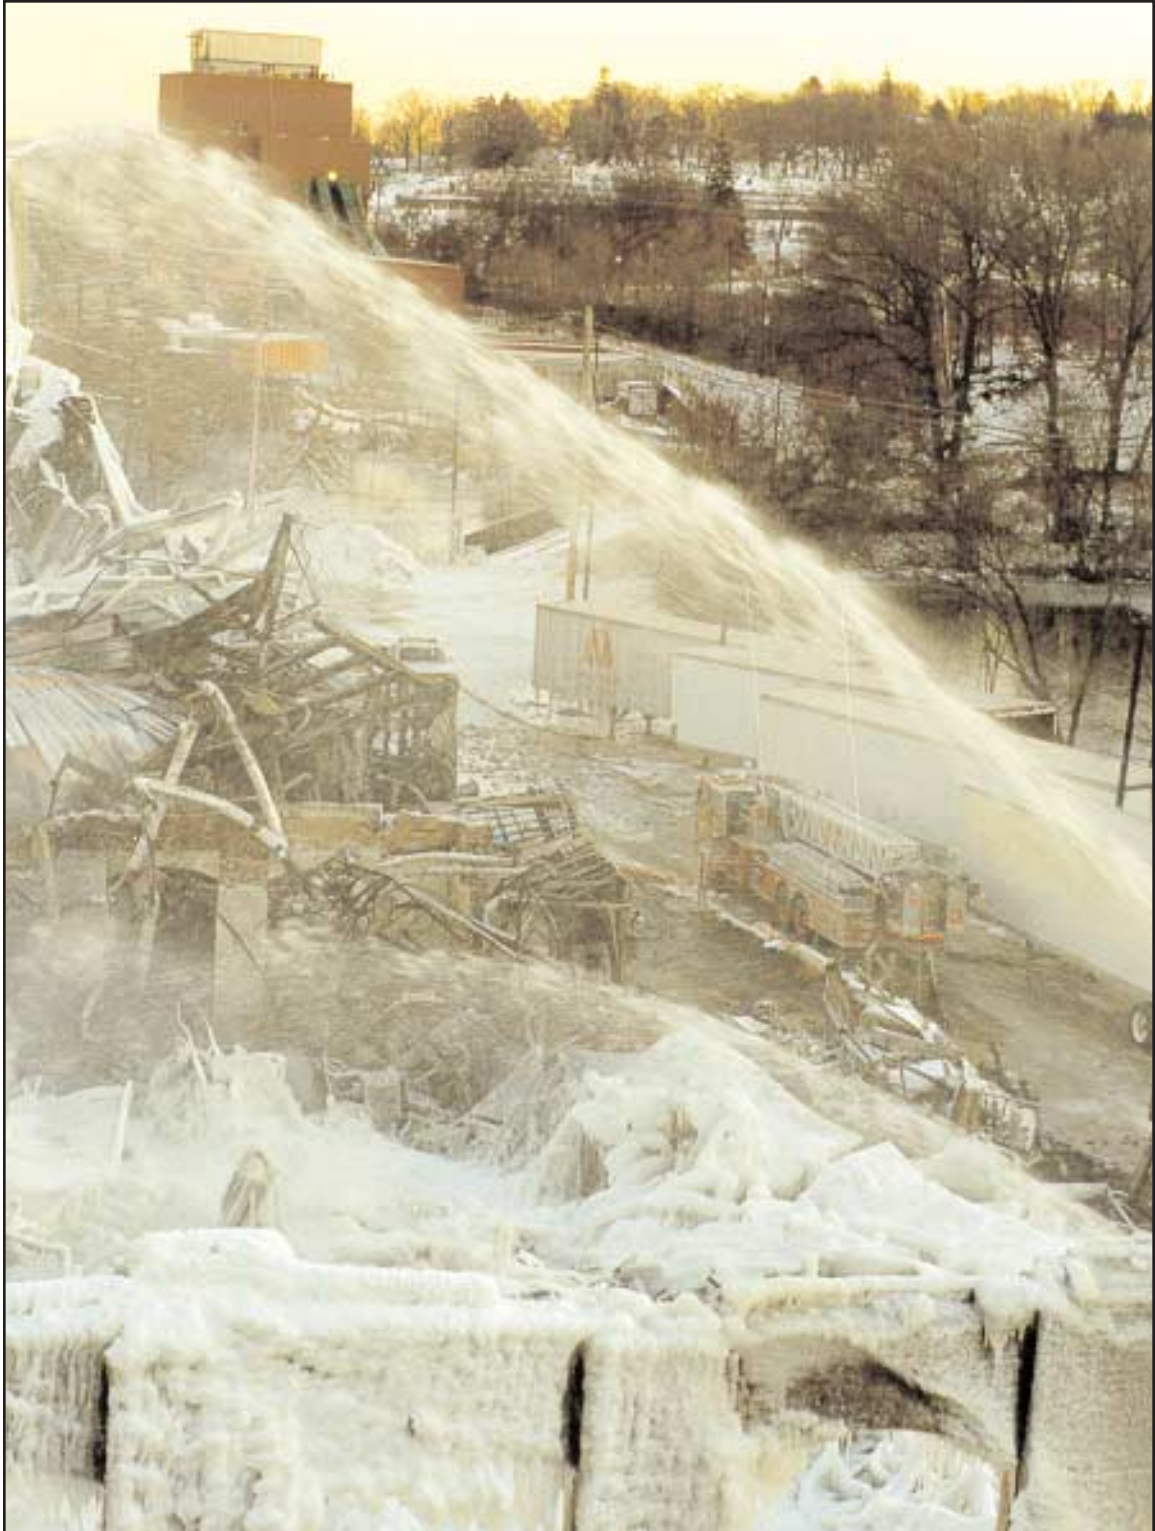
Mop-up operations on the west side of the site. The bridge over the Spickett River is in the background. Note the tight conditions and truck trailer parking.

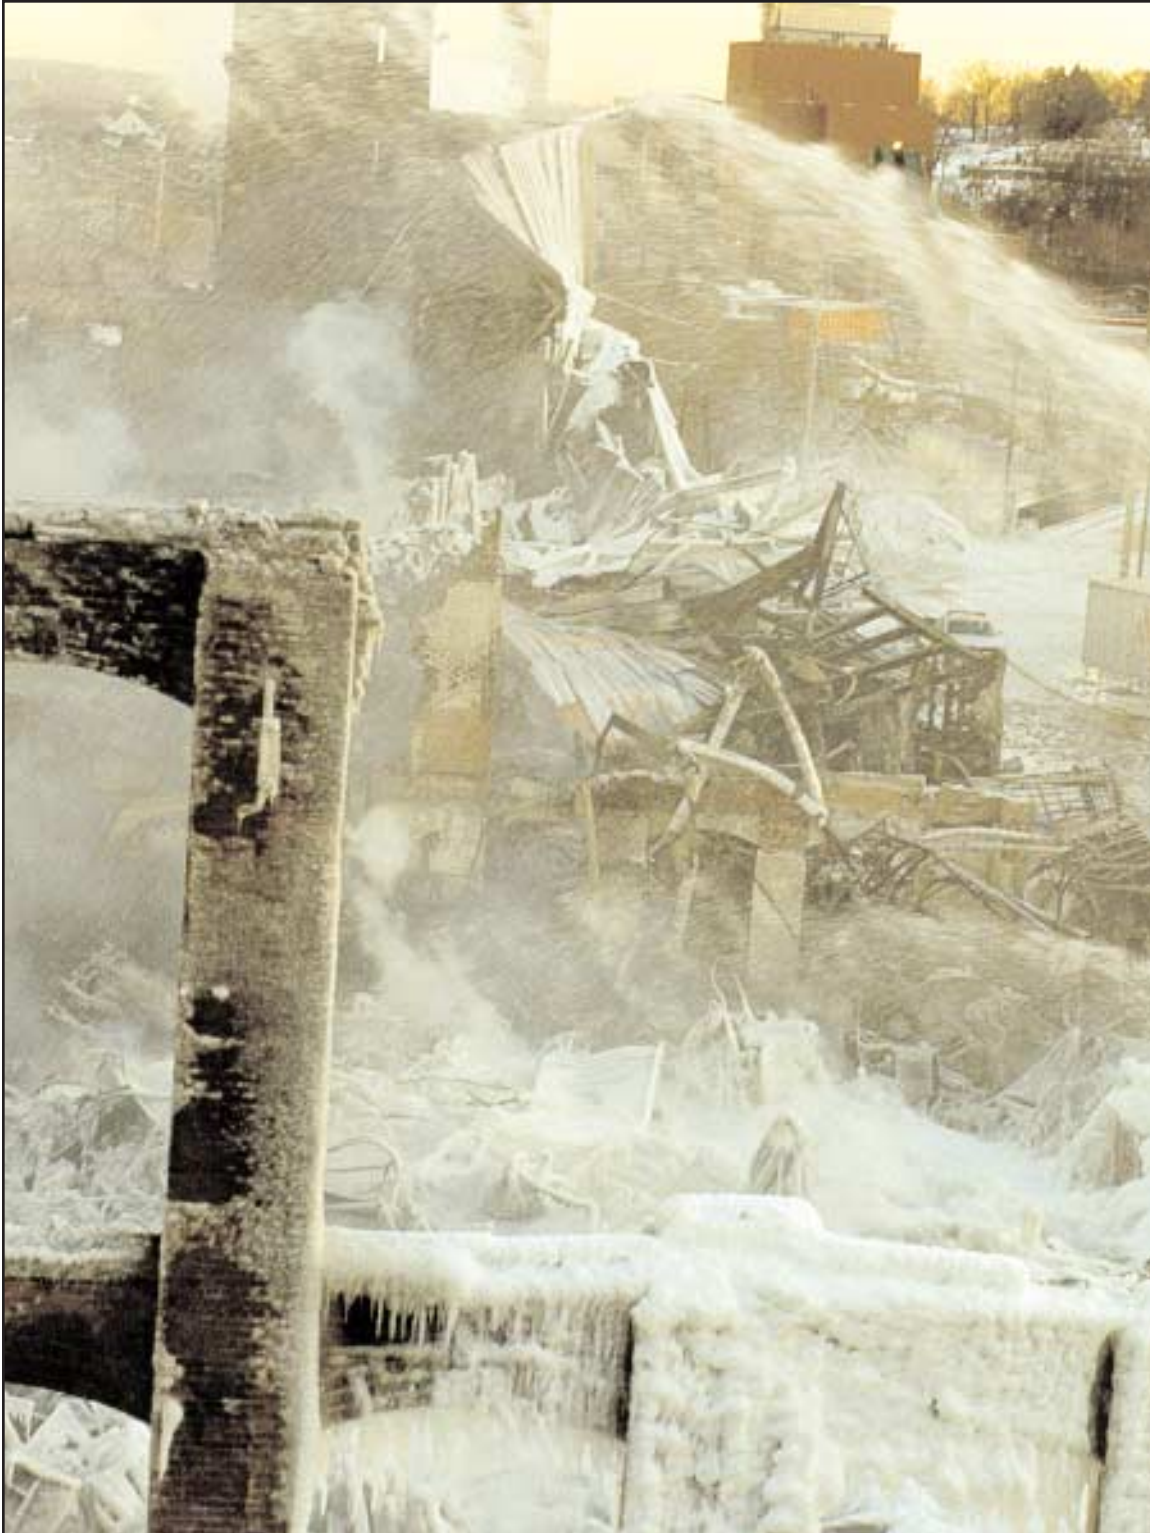
5. Remains of the Monomac Building looking to the south.

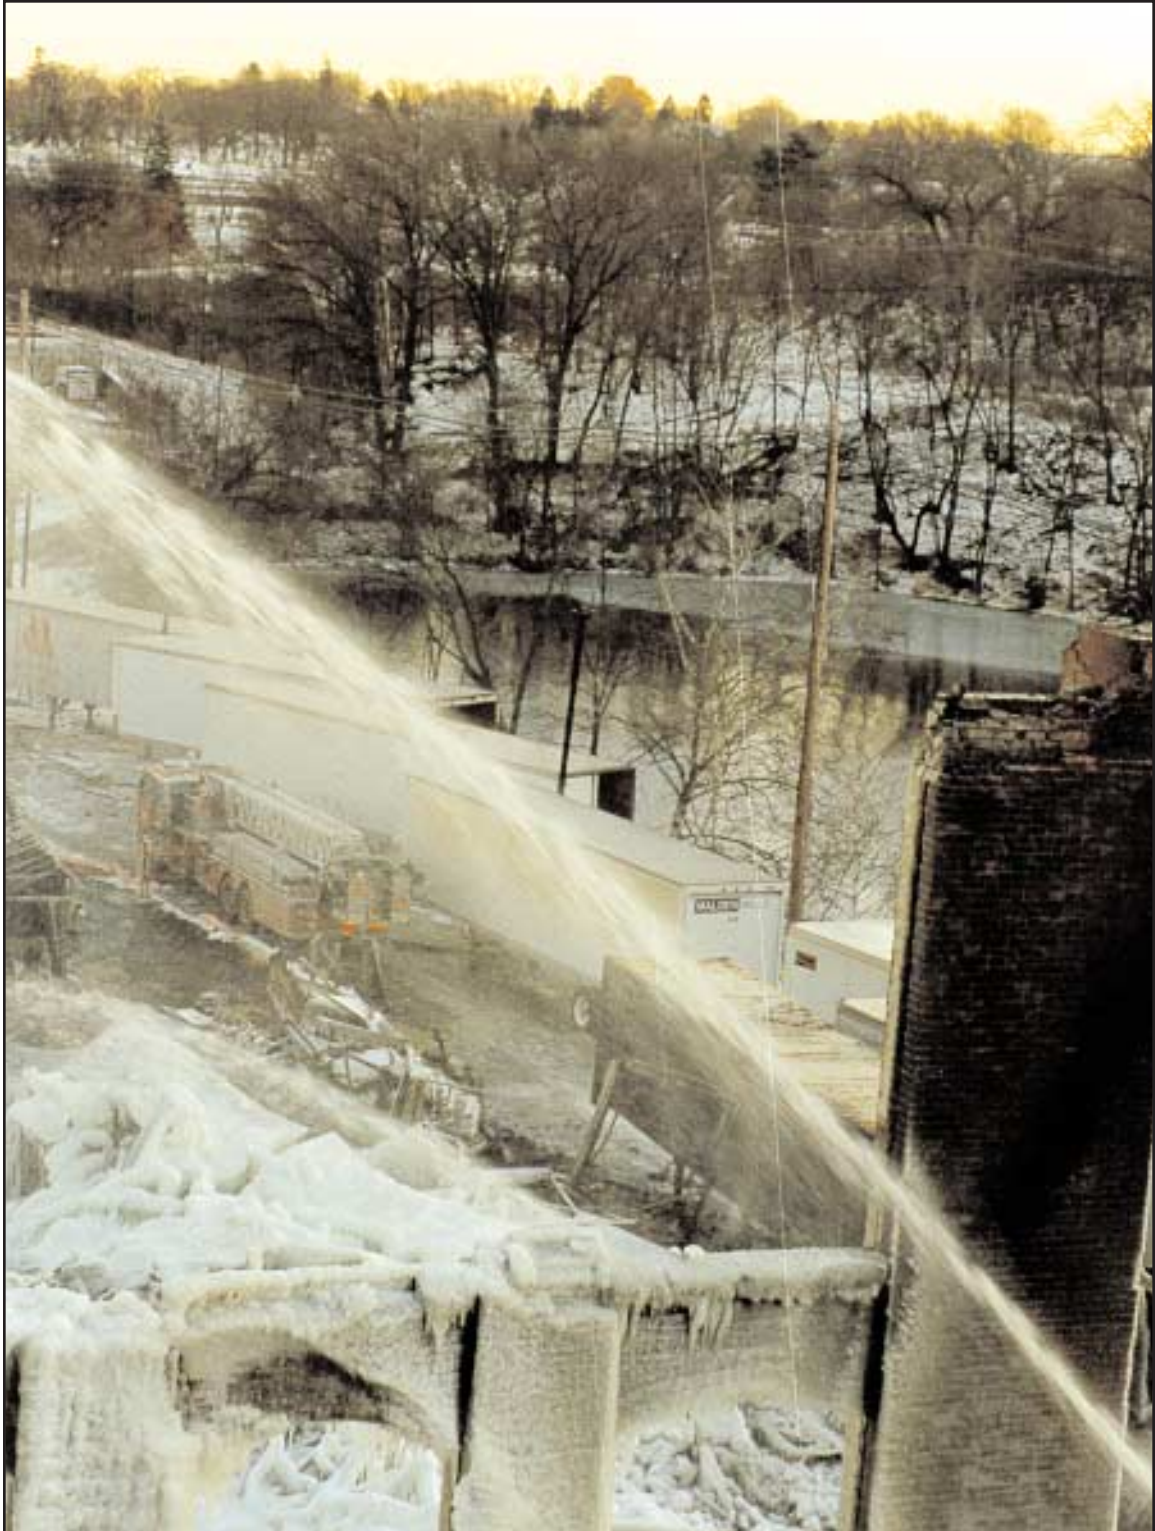
6. Conditions on the west side of the site with the truck trailers and the Spickett River.

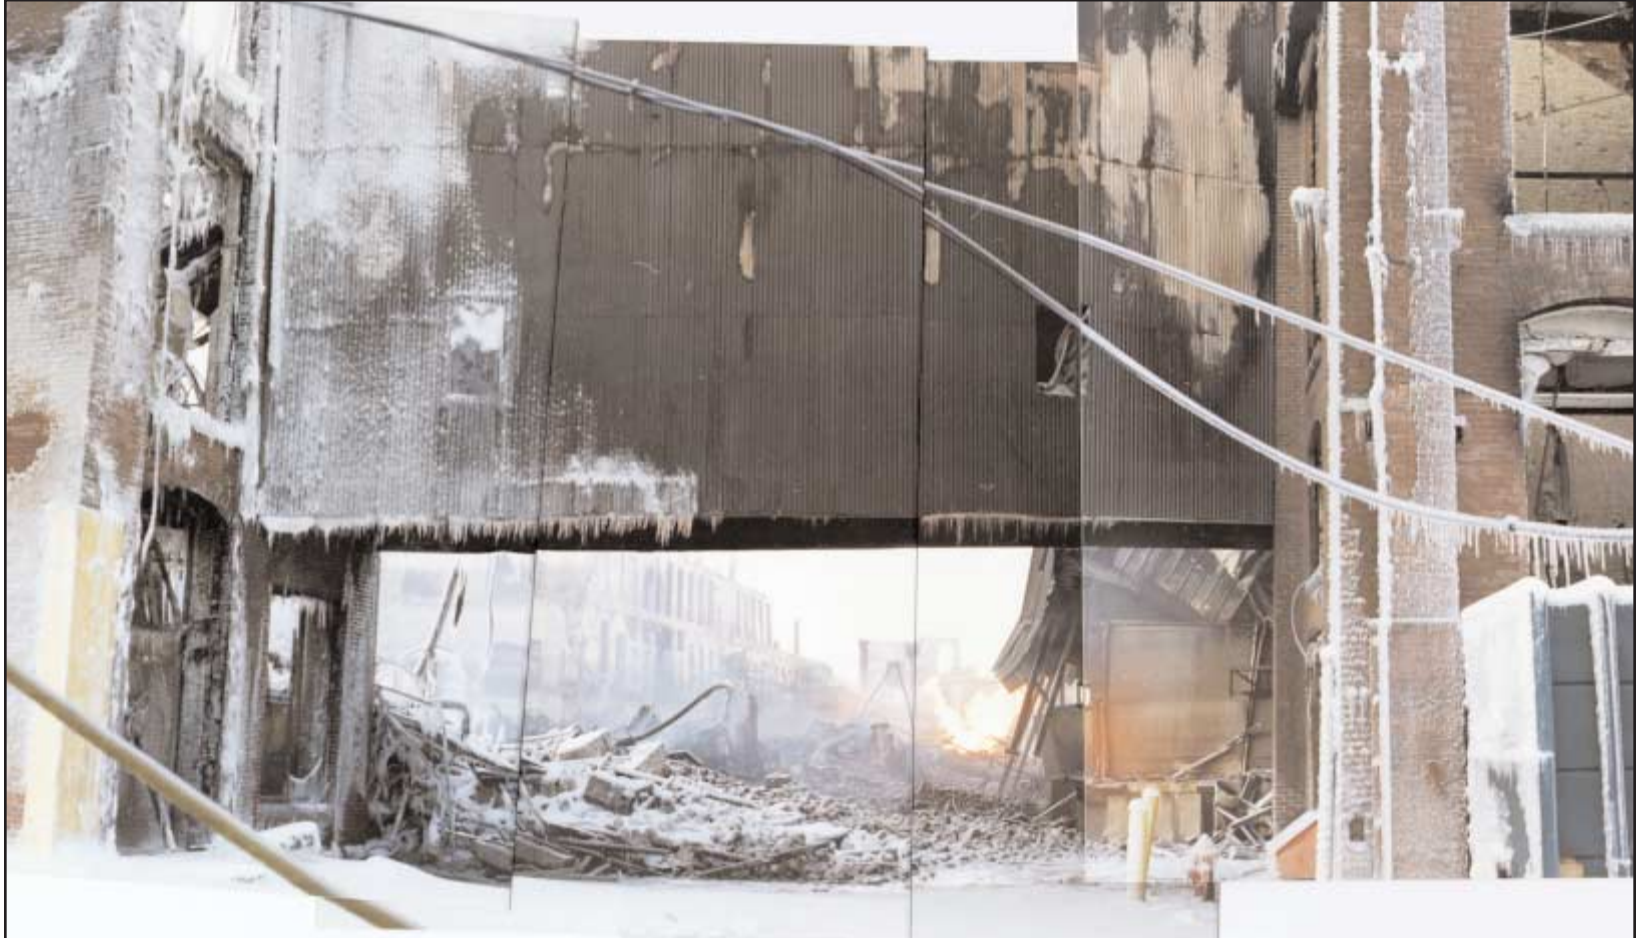
7. Composite of the overhead connecting bridge between the Monomac and Process buildings.

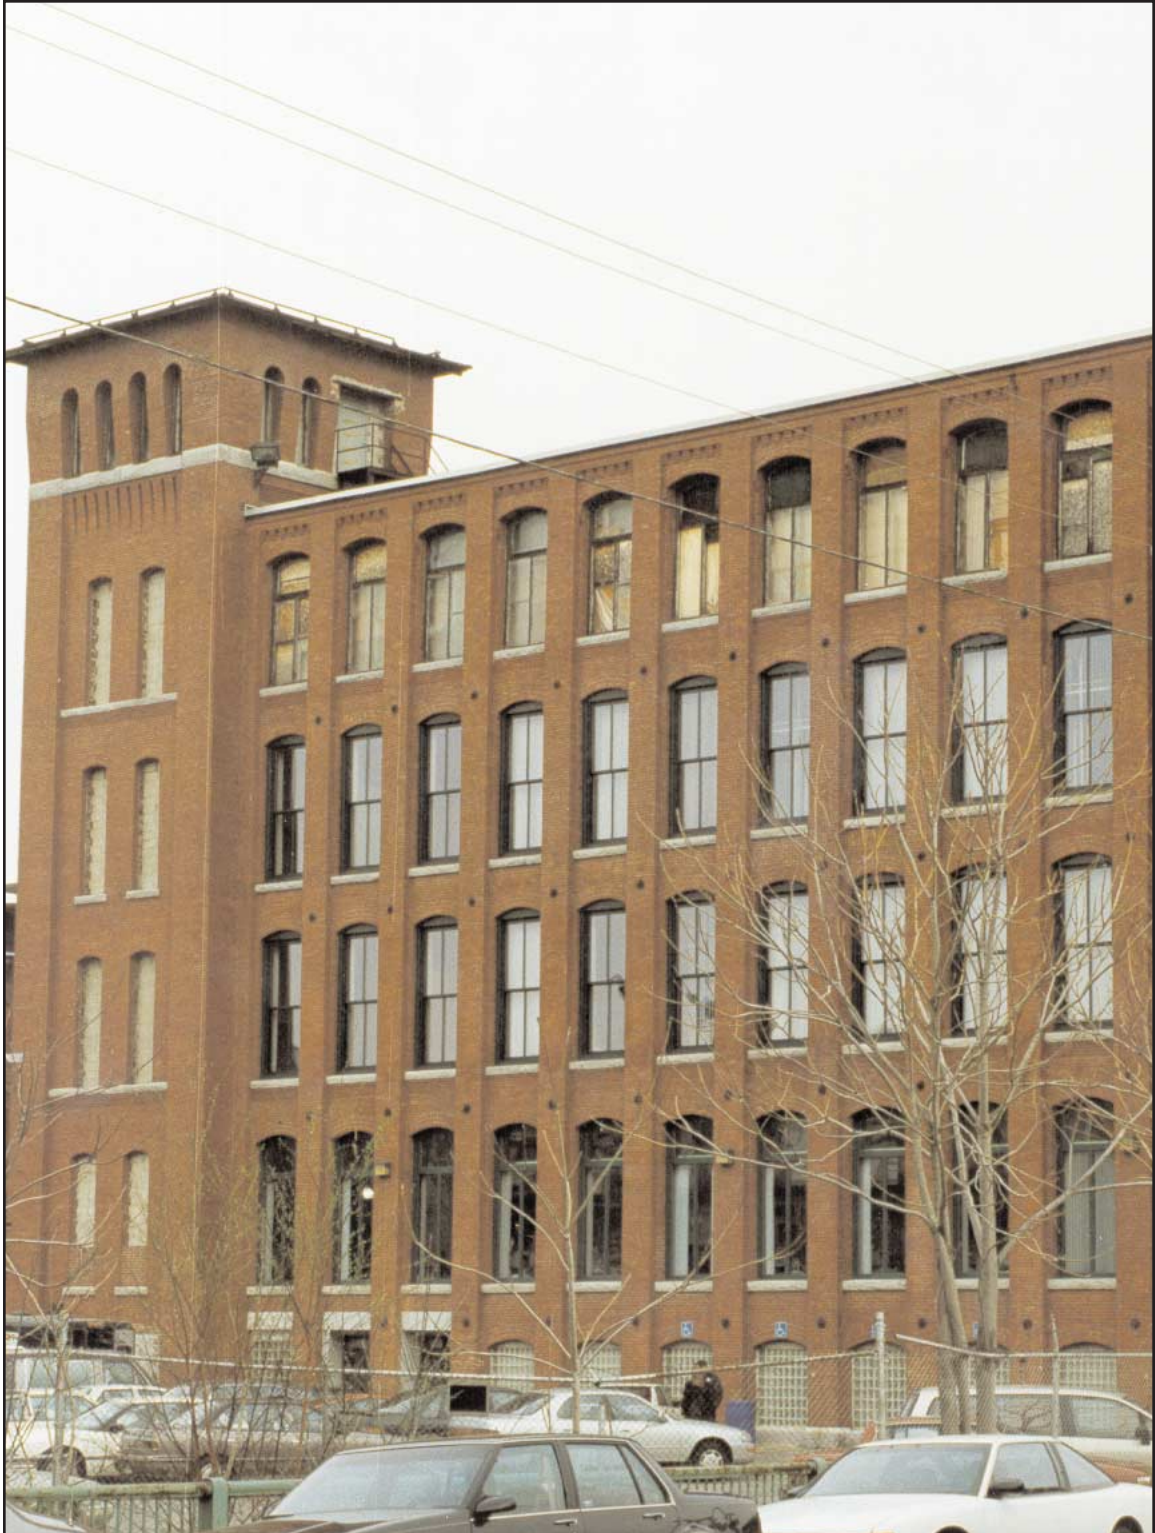
10. Example of the heavy masonry buildings that were involved in the fire.

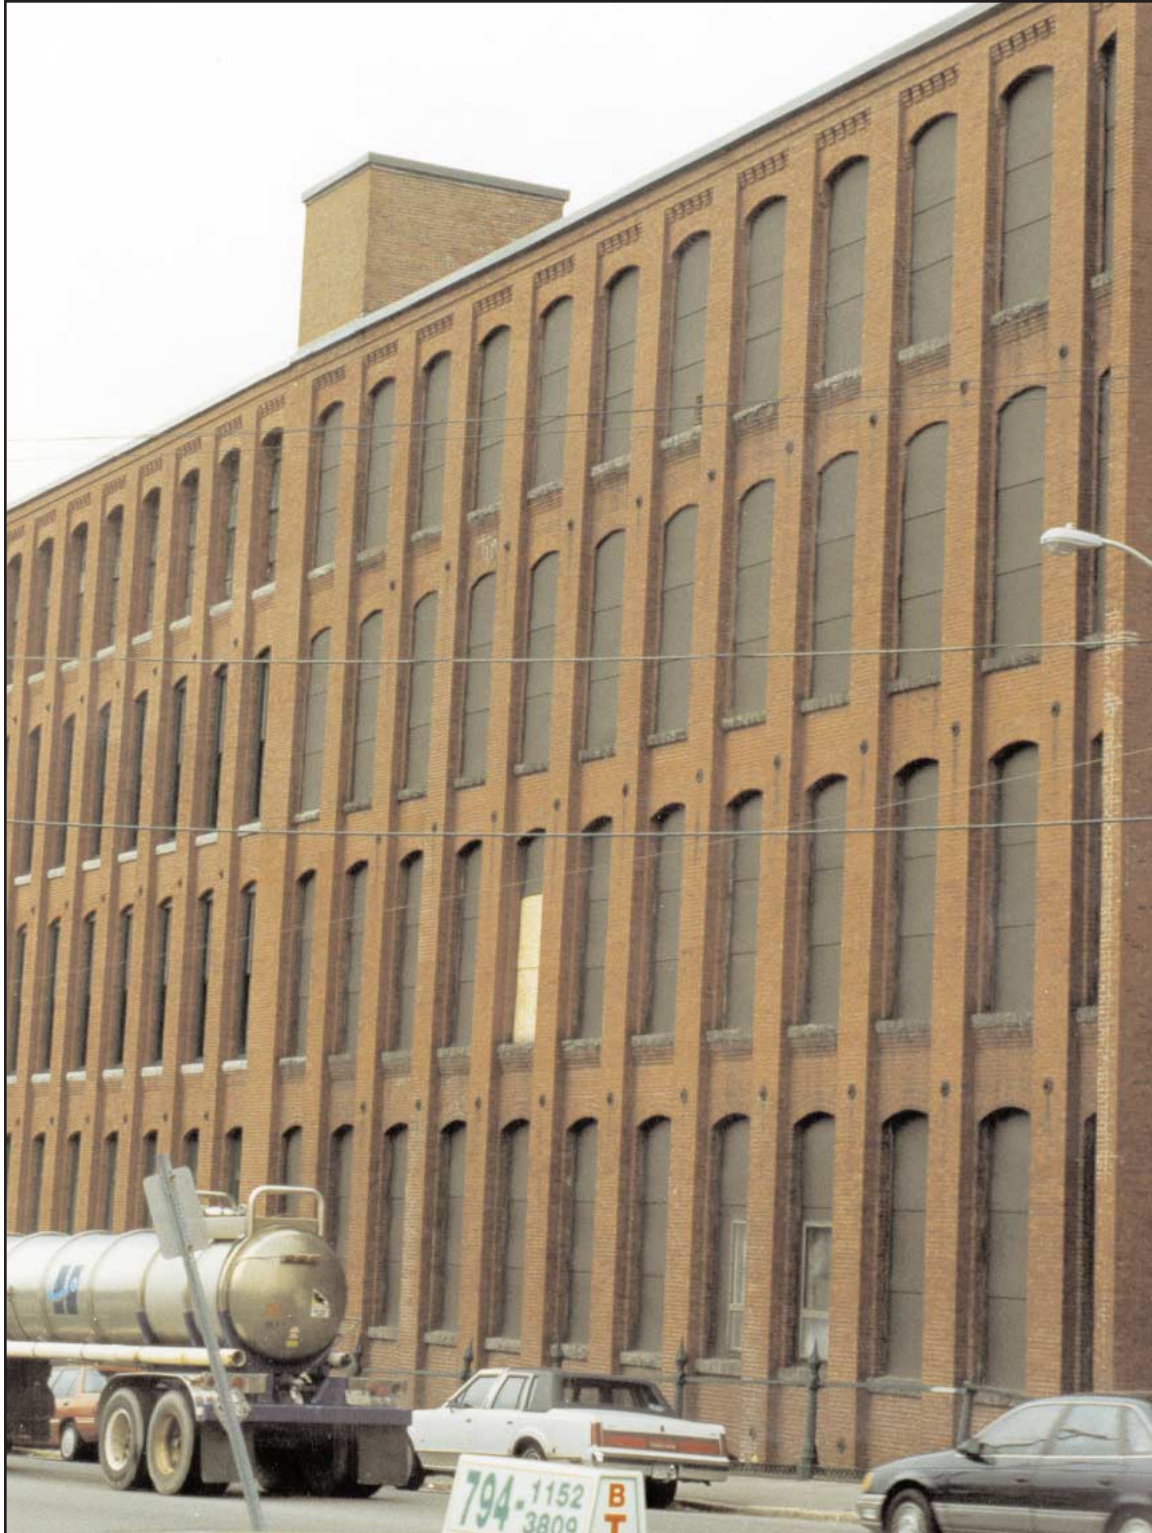
11. Windows once needed for natural light have been covered over, making visible fire location difficult. In addition, depending on the materials used, ventilation may be difficult.

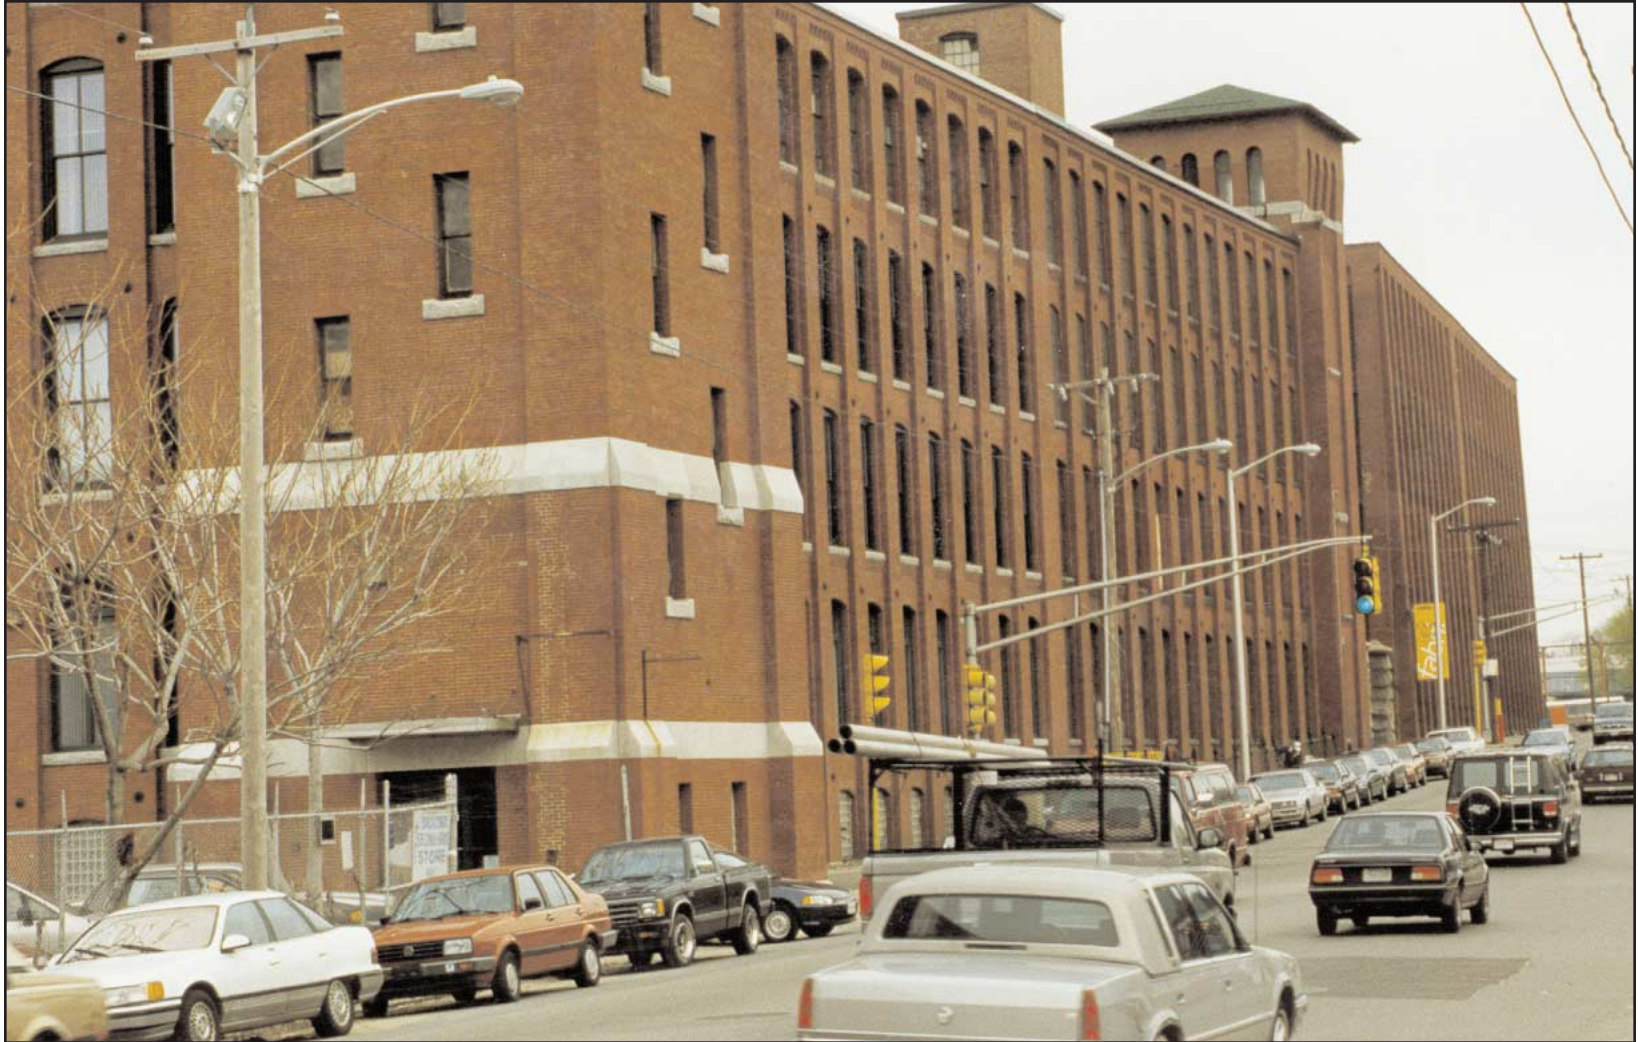
12. An idea of the scale of the combustible mill buildings that were involved in this incident.
