# **Urban Wildlands Fire Pebble Beach, California (May 31, 1987)**

**Investigated by: Hugh W. Graham**

**This is Report 007 of the Major Fires Investigation Project conducted by TriData Corporation under contract EMW-86-C-2277 to the United States Fire Administration, Federal Emergency Management Agency.**

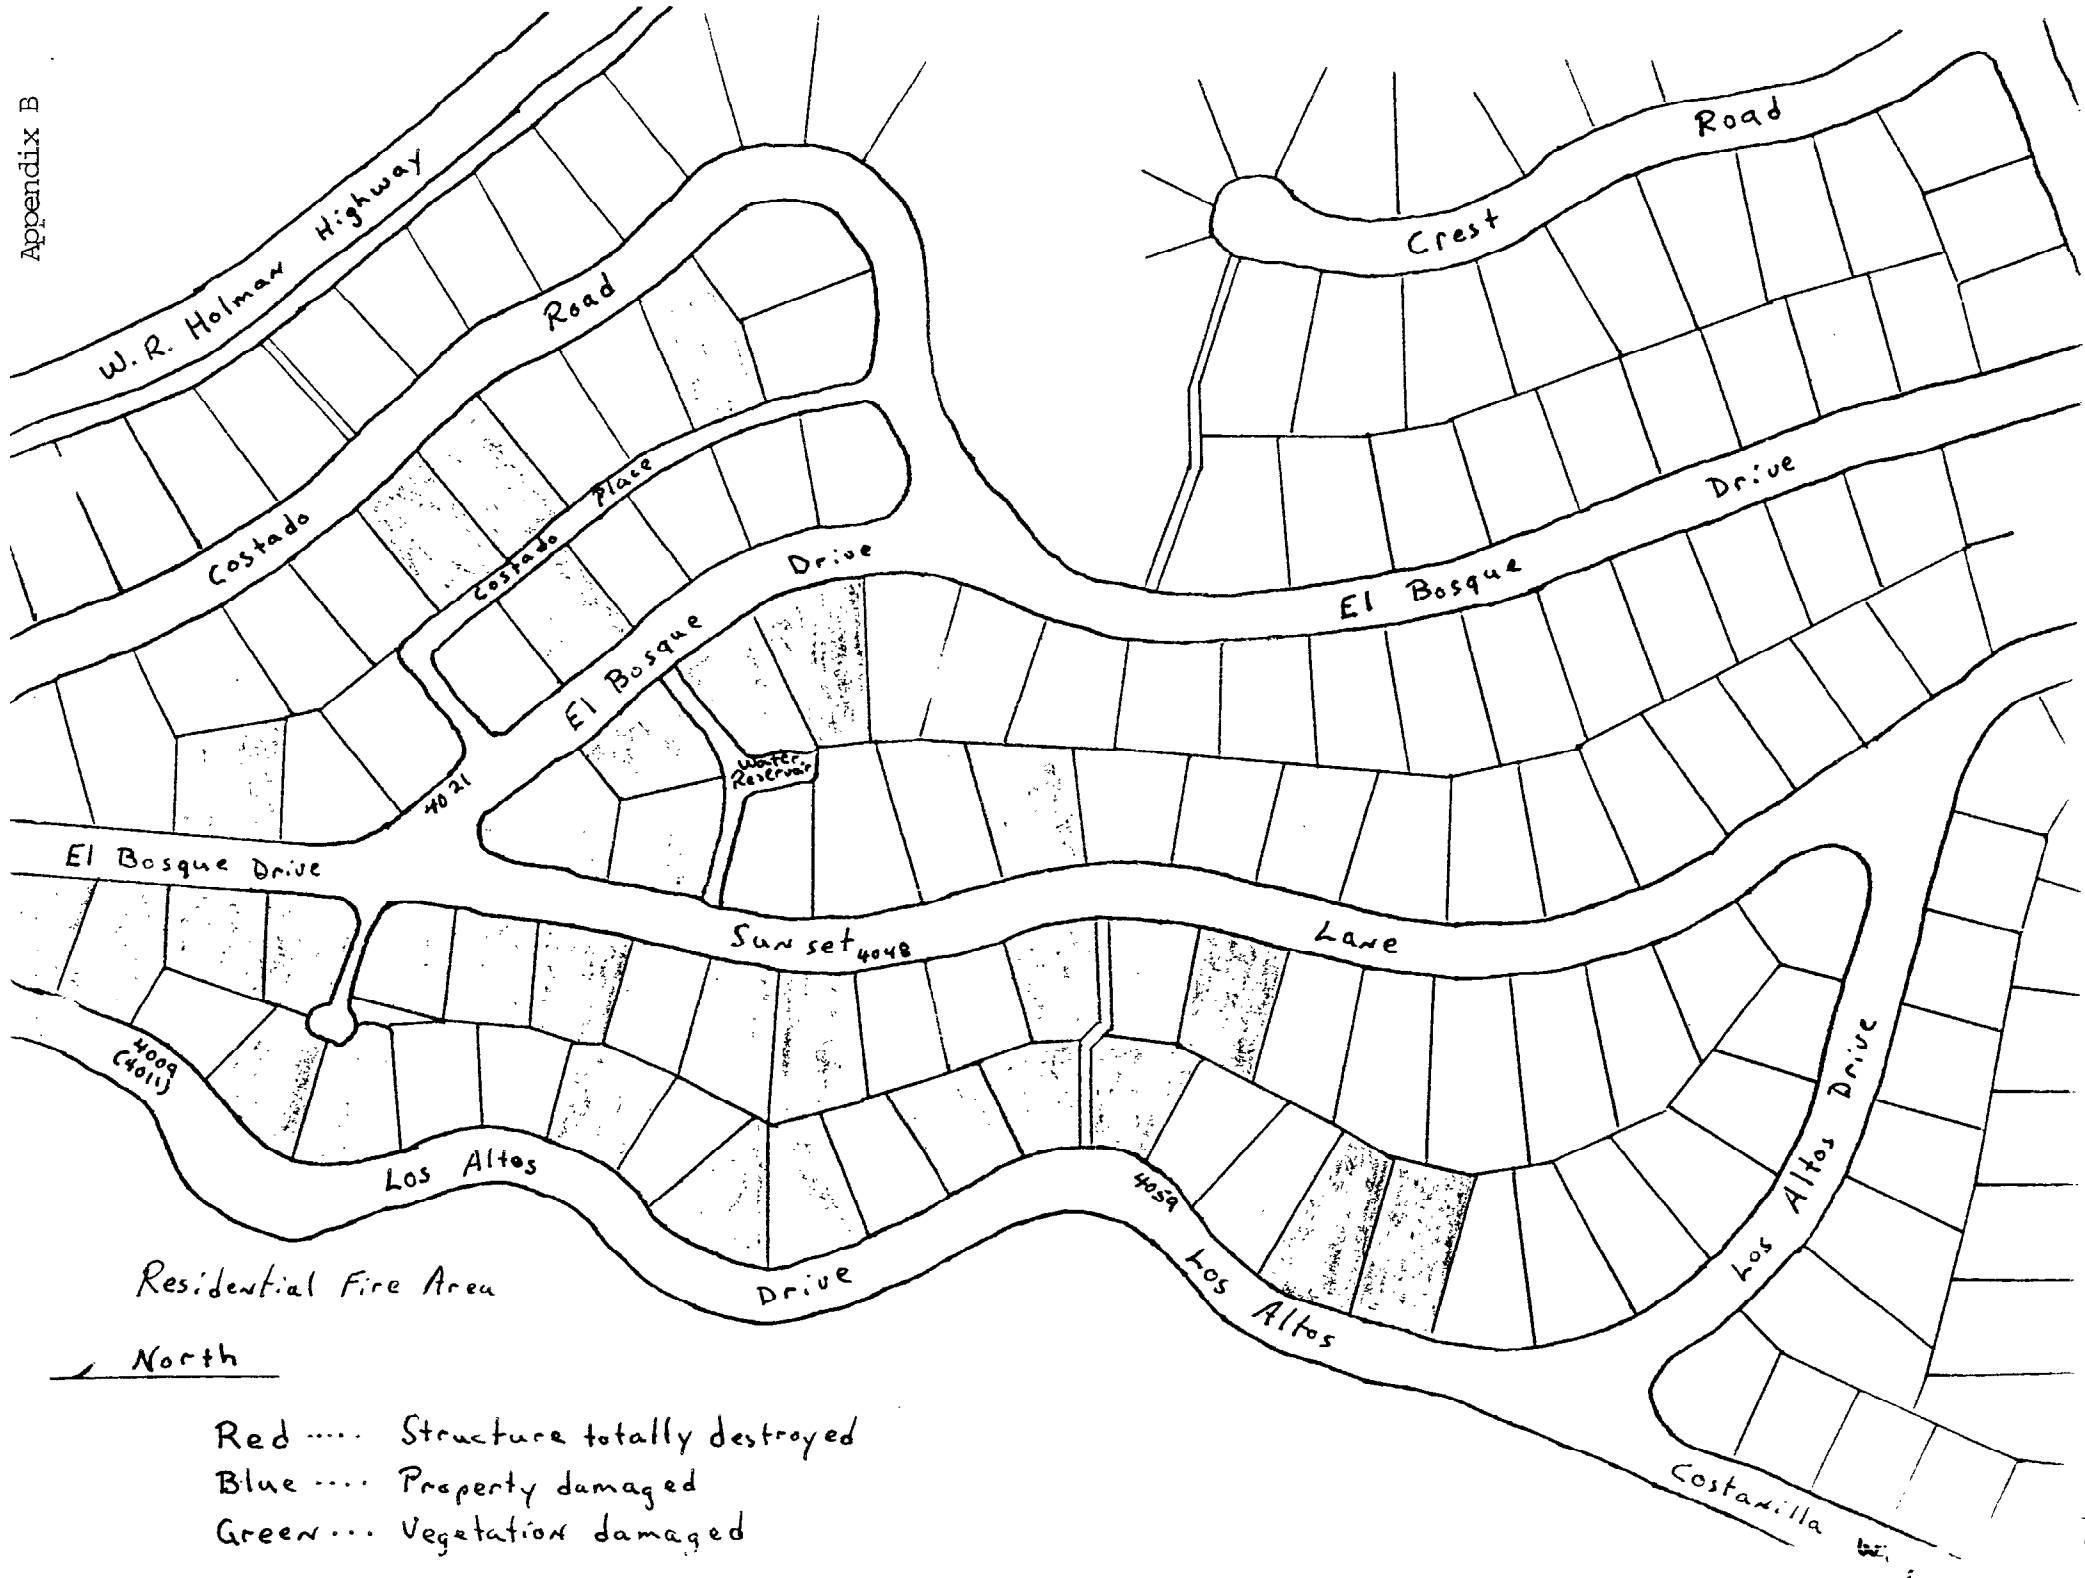
Residential Fire Area

- Red ..... Structure totally destroyed
- Blue ..... Property damaged
- Green ... Vegetation damaged

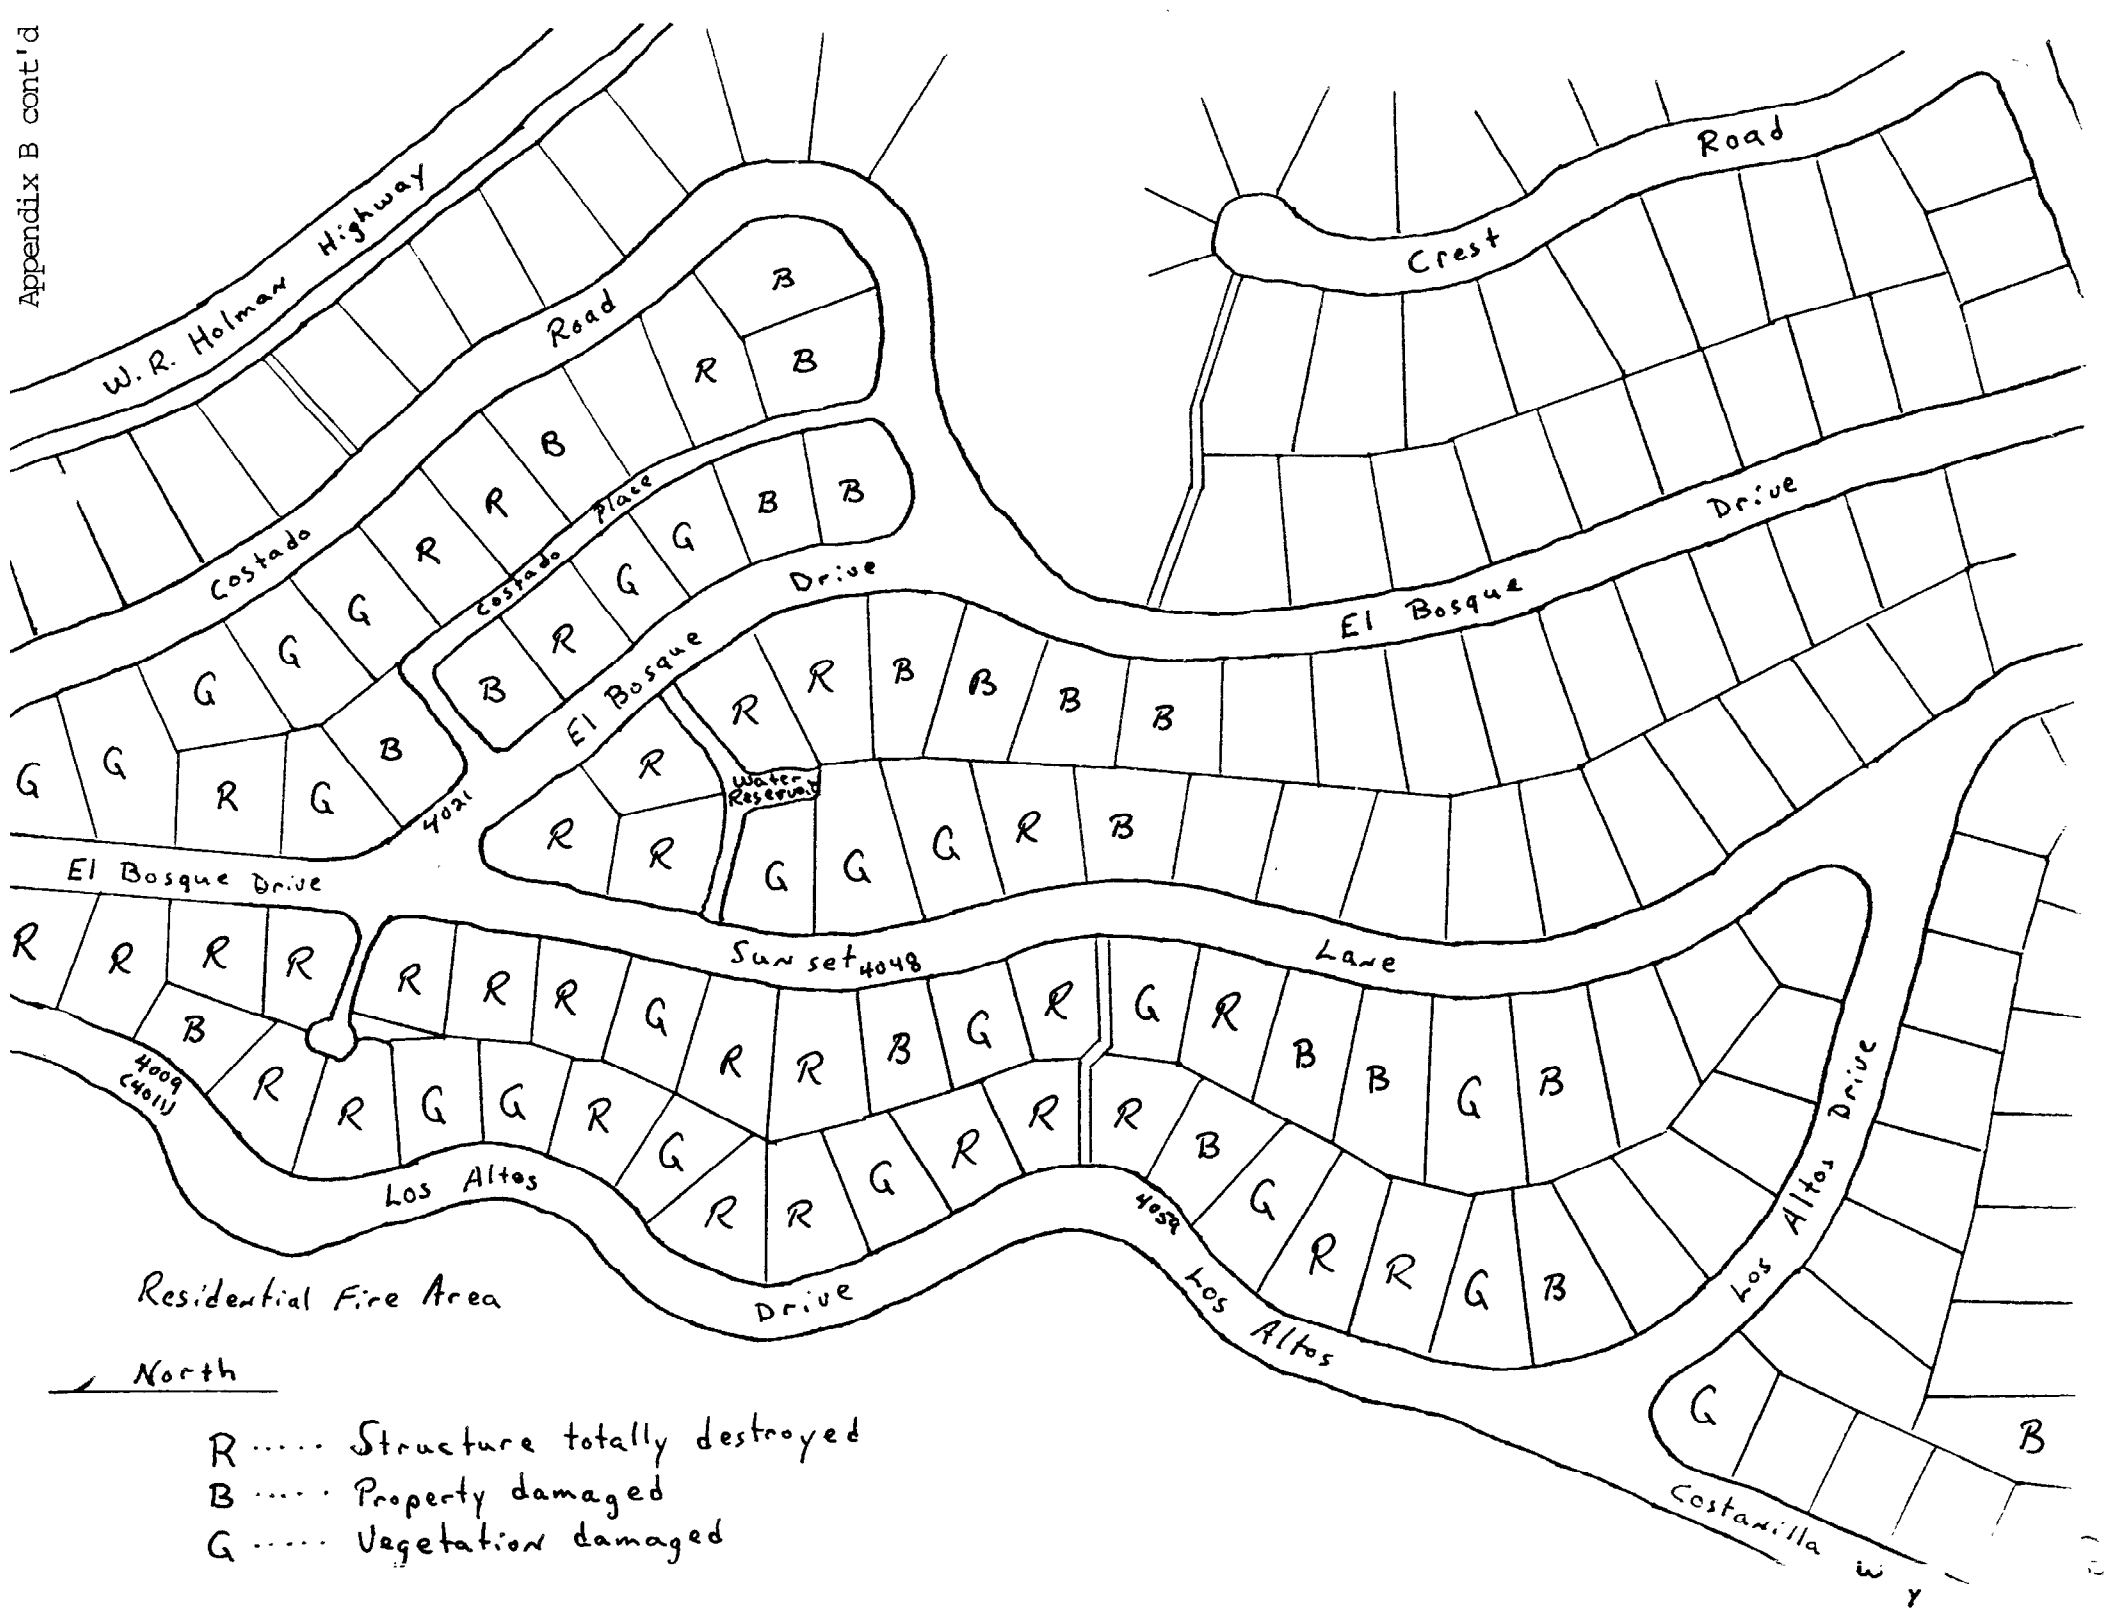
Residential Fire Area

- R ..... Structure totally destroyed
- B ..... Property damaged
- G ..... Vegetation damaged
