Four Firefighters Killed, Trapped by Floor Collapse Brackenridge, Pennsylvania

**Four Firefighters Killed,
Trapped by Floor Collapse
Brackenridge, Pennsylvania
(December 20, 1991)**

**This is Report 061 of the Major Fires Investigation Project conducted
by TriData Corporation under contract EMW-90-C-3338 to the United
States Fire Administration, Federal Emergency Management Agency.**

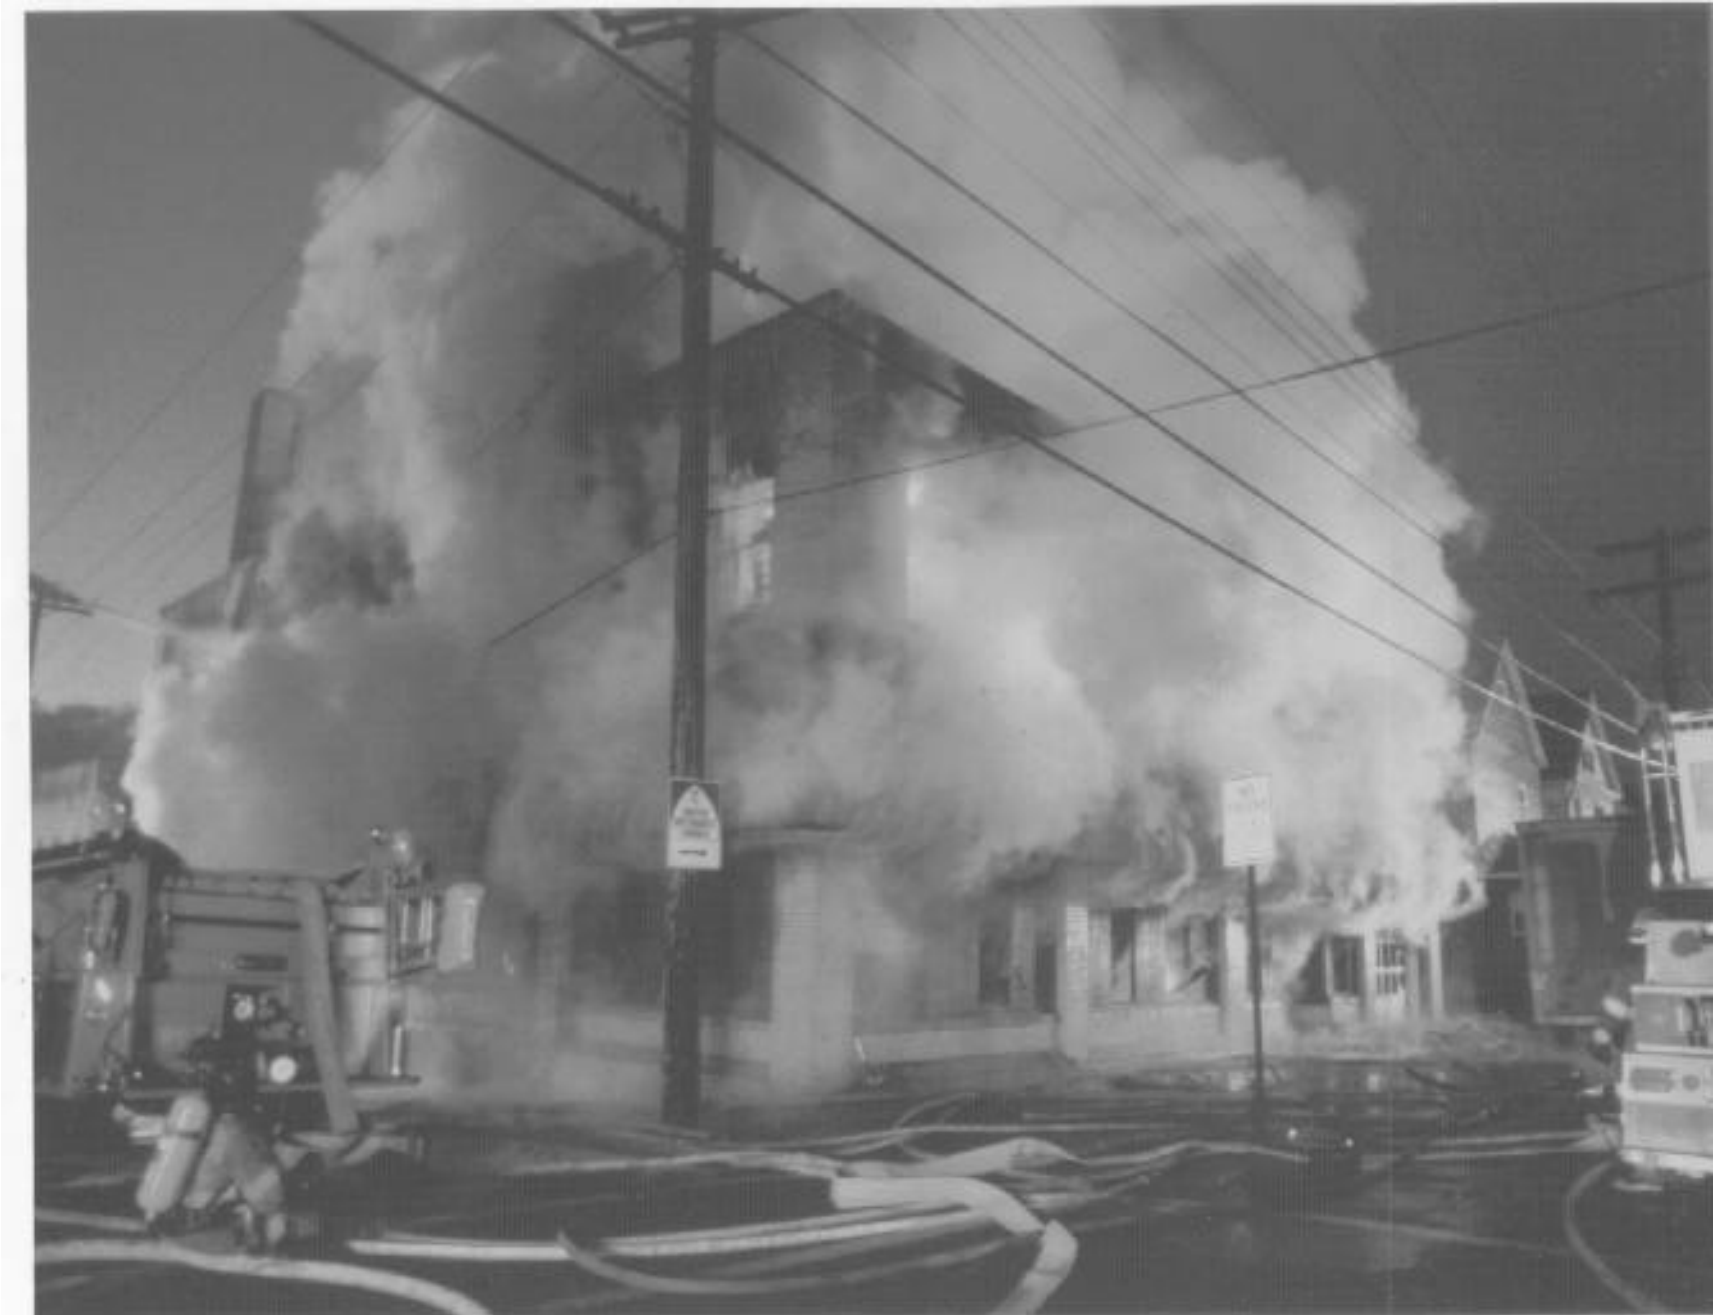
At the height of the fire; firefighters have pulled back.

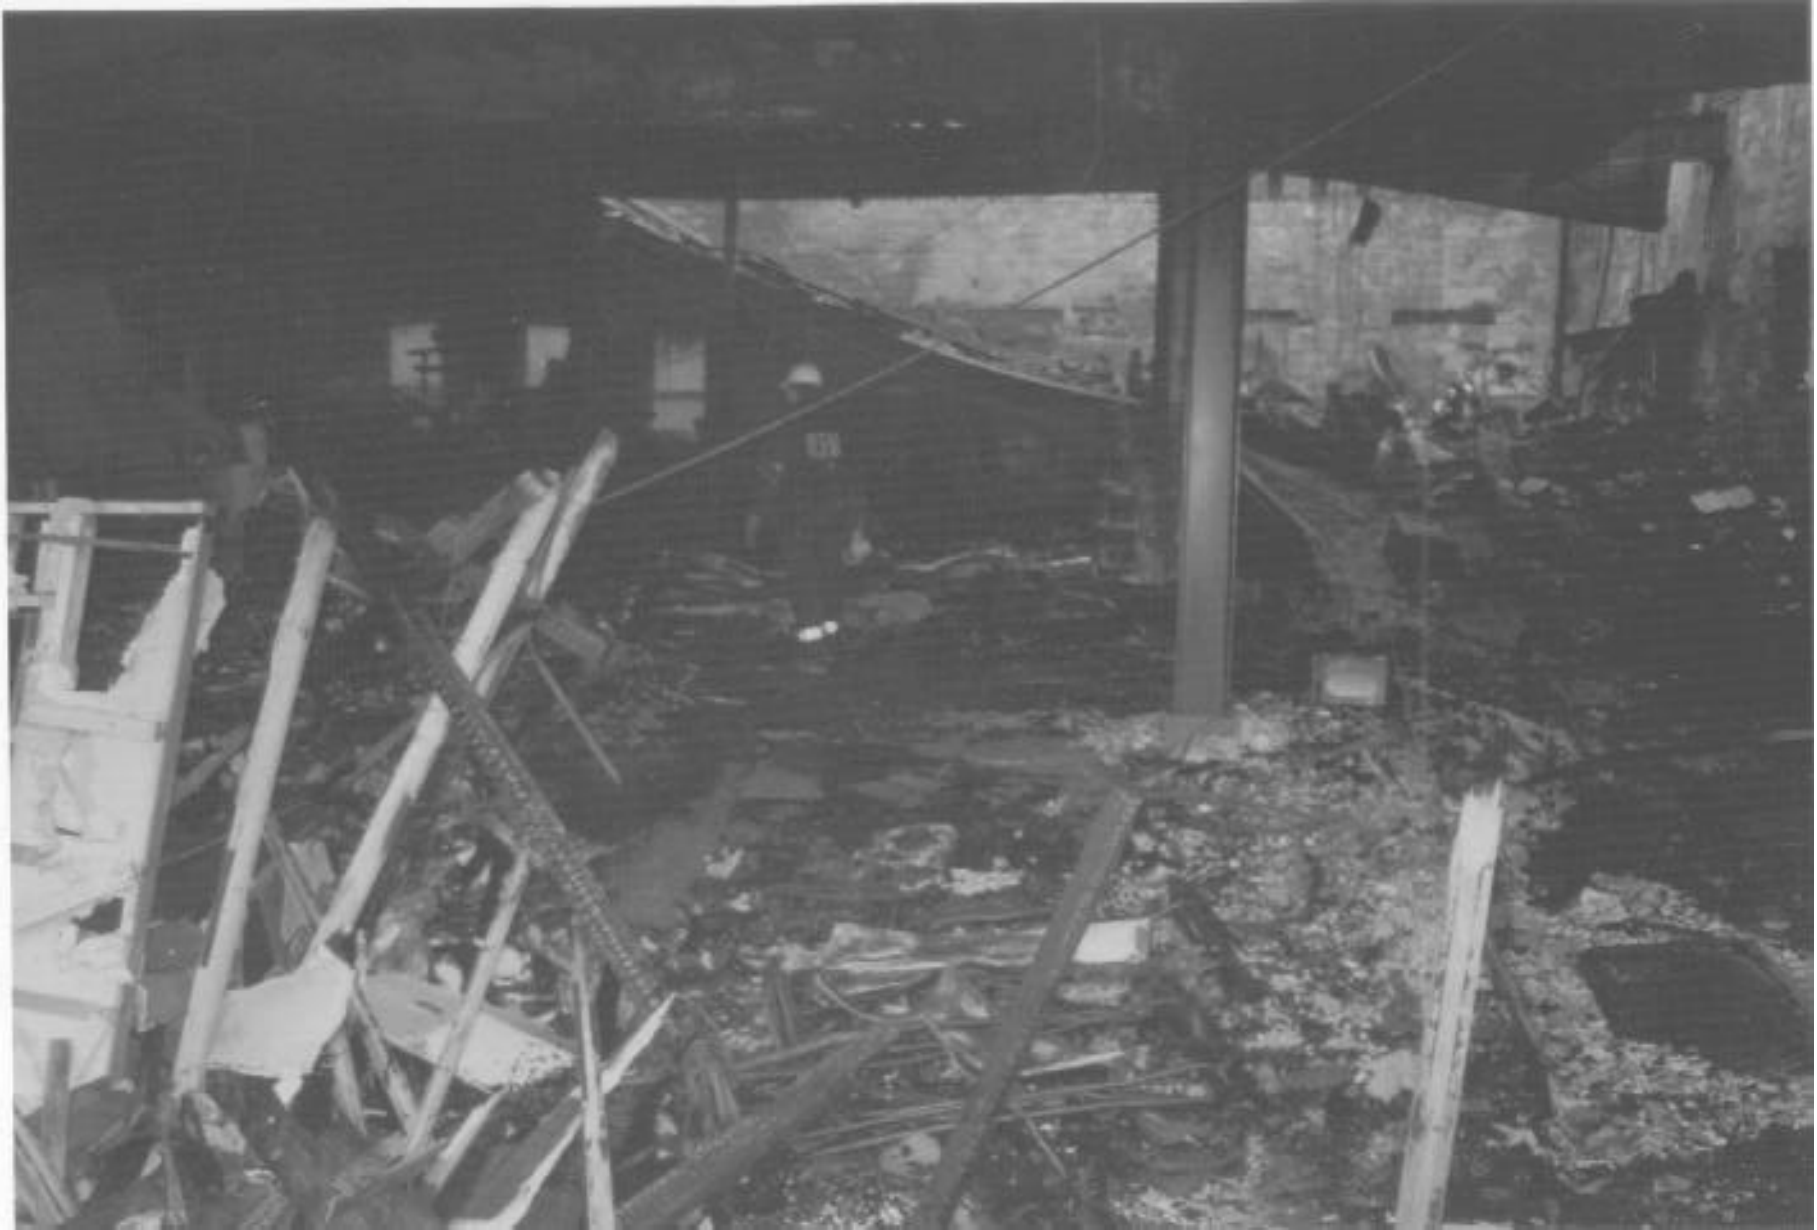
Ground floor area, showing unprotected steel column and ramp to second floor.

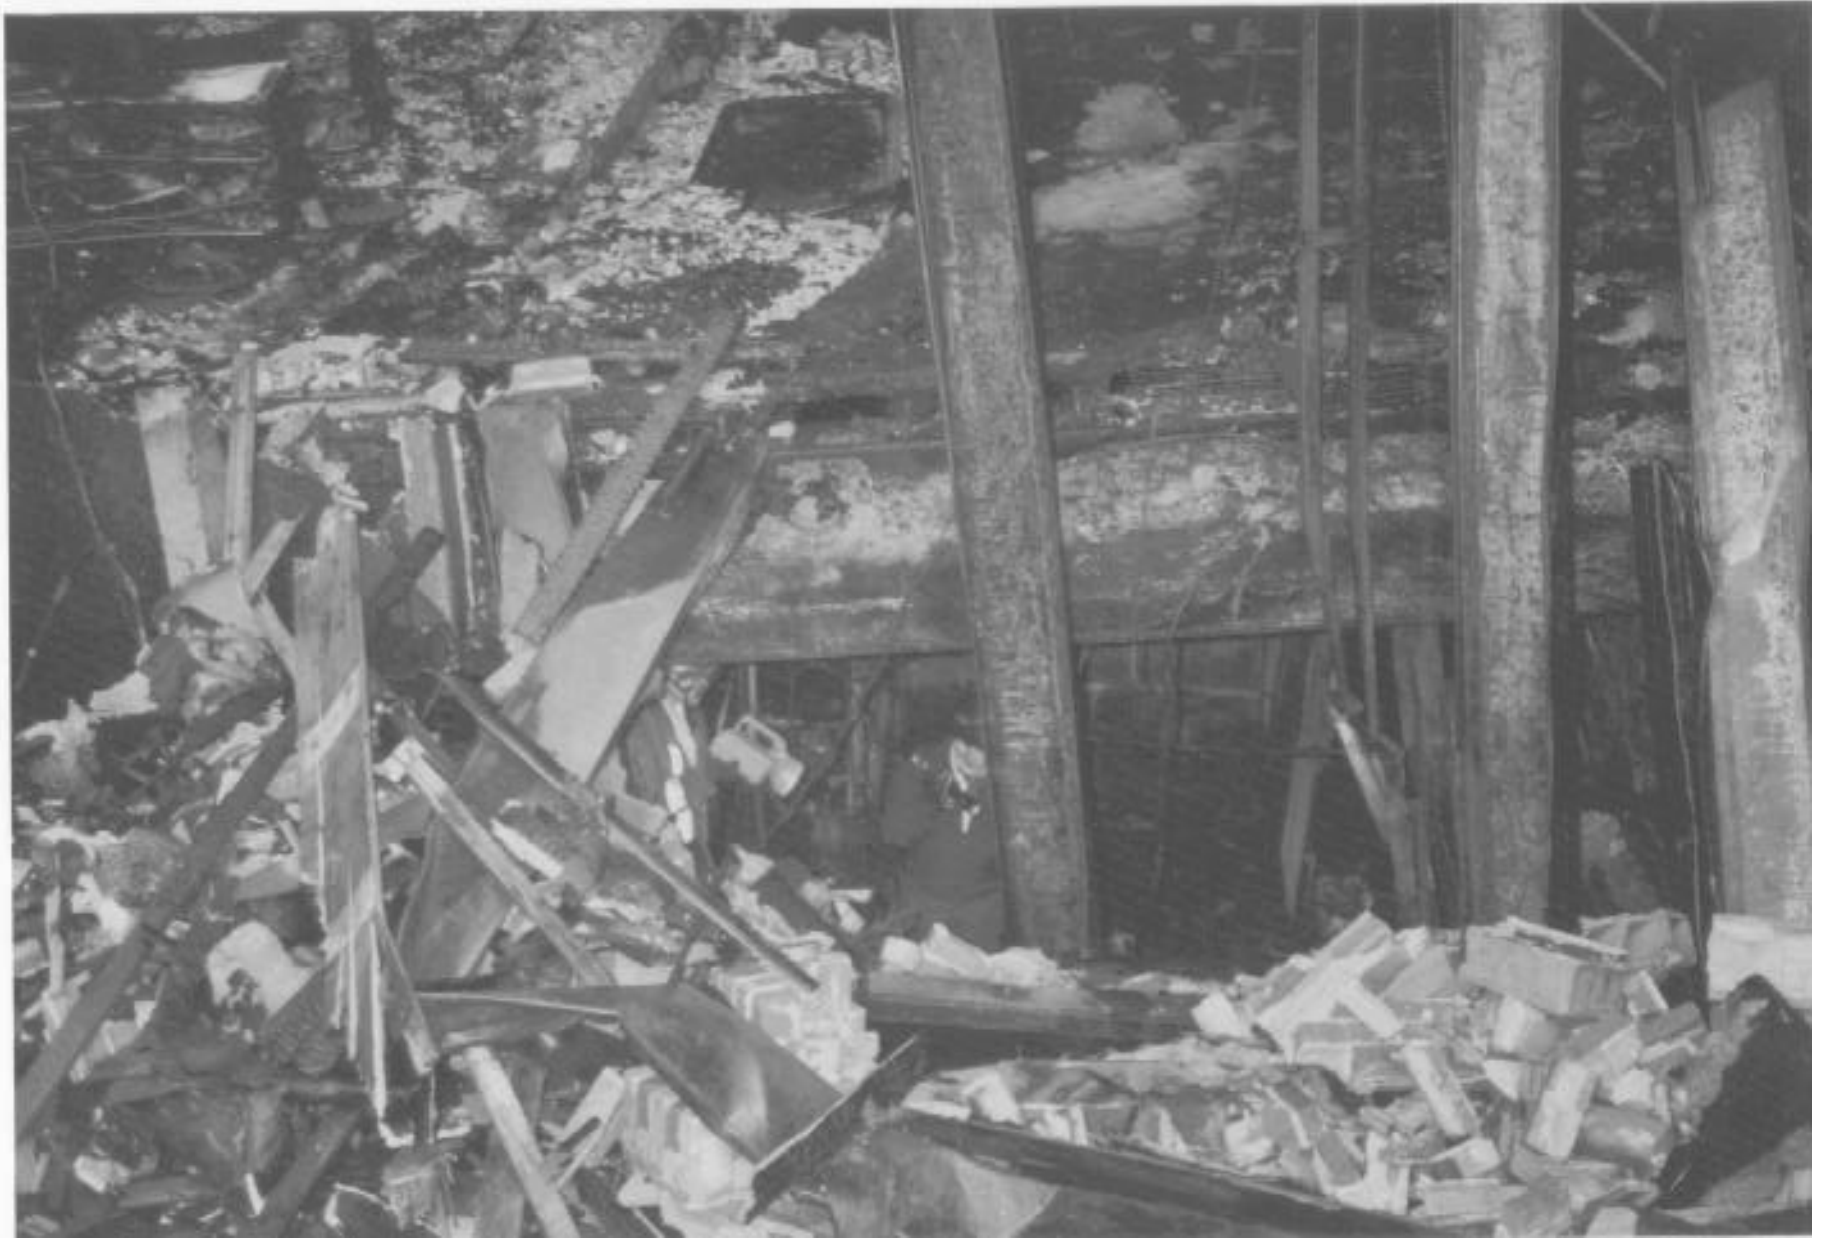
View from sidewalk in front of building (Brackenridge Ave.) looking into basement.
Note thin concrete slab, supported by steel joists resting on steel beams.

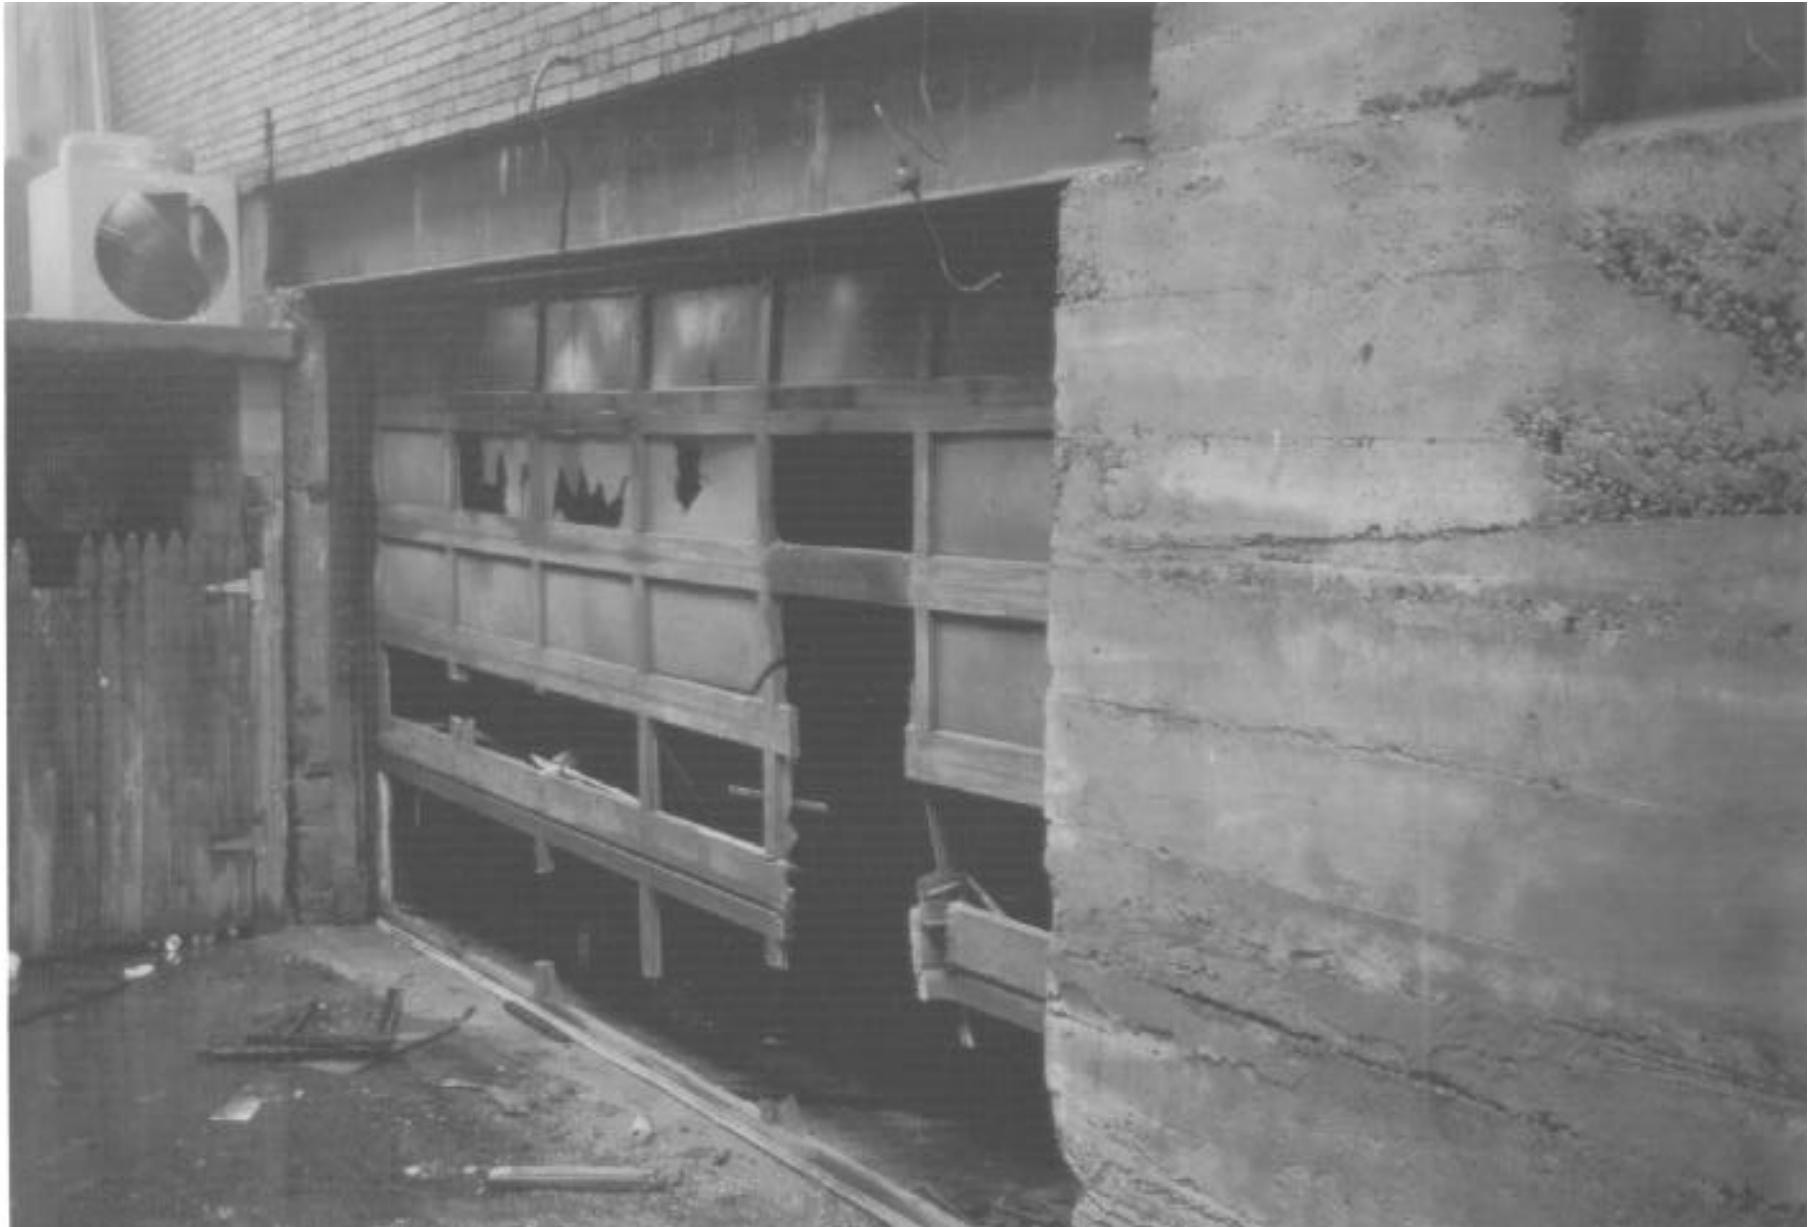
Roll-up door at the rear of the fire building has been cut with circular saws to allow crews to enter the basement.
Initial entry by Eureka crew was through the bottom panels - larger opening was made later.

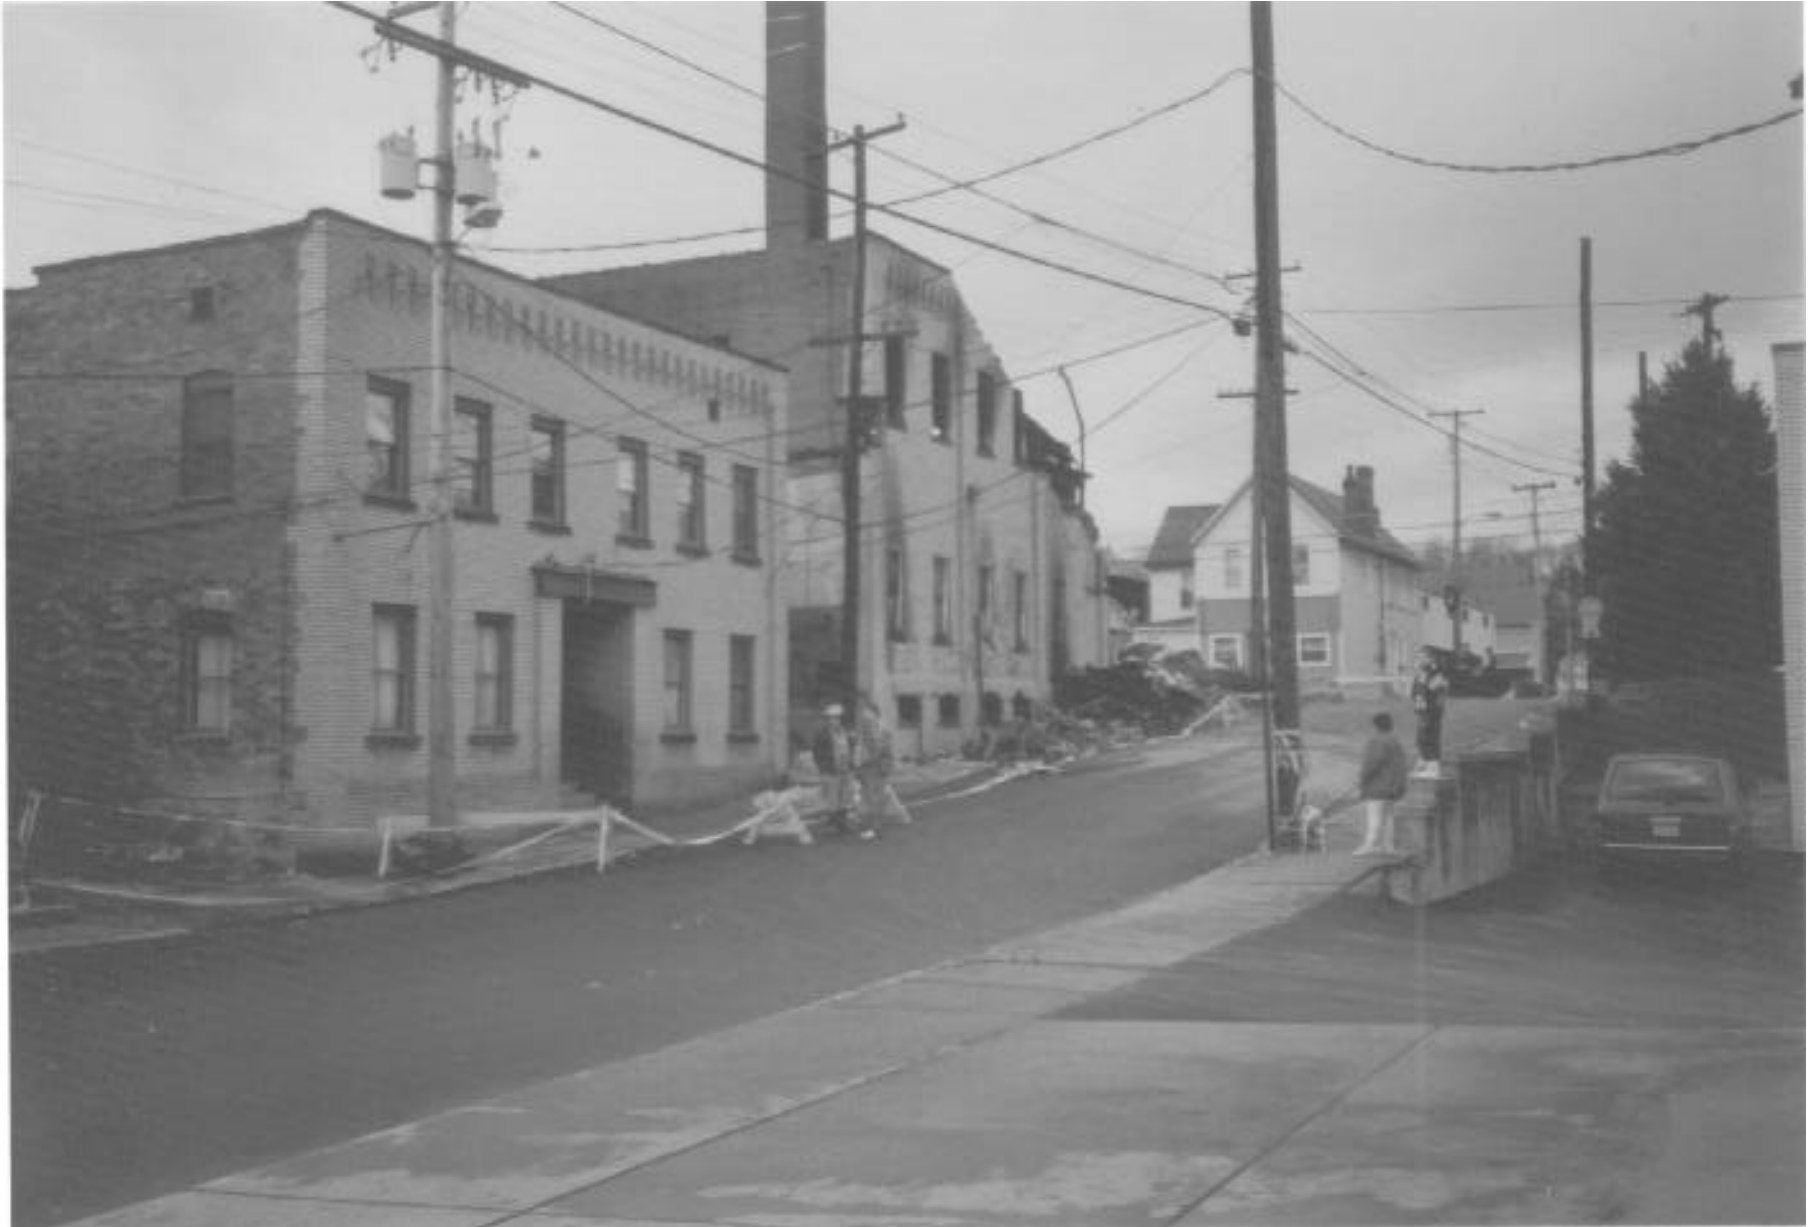
Looking from Pioneer Hose Company Station 50 toward fire building. Entrance to rear driveway (access to basement) is between buildings. Bridge once spanned driveway from second floor of building on left to the fire building.
