## Manufacturing Mill Fire Methuen, Massachusetts

# **Manufacturing Mill Fire Methuen, Massachusetts**

# Manufacturing Mill Fire

December 11, 1995

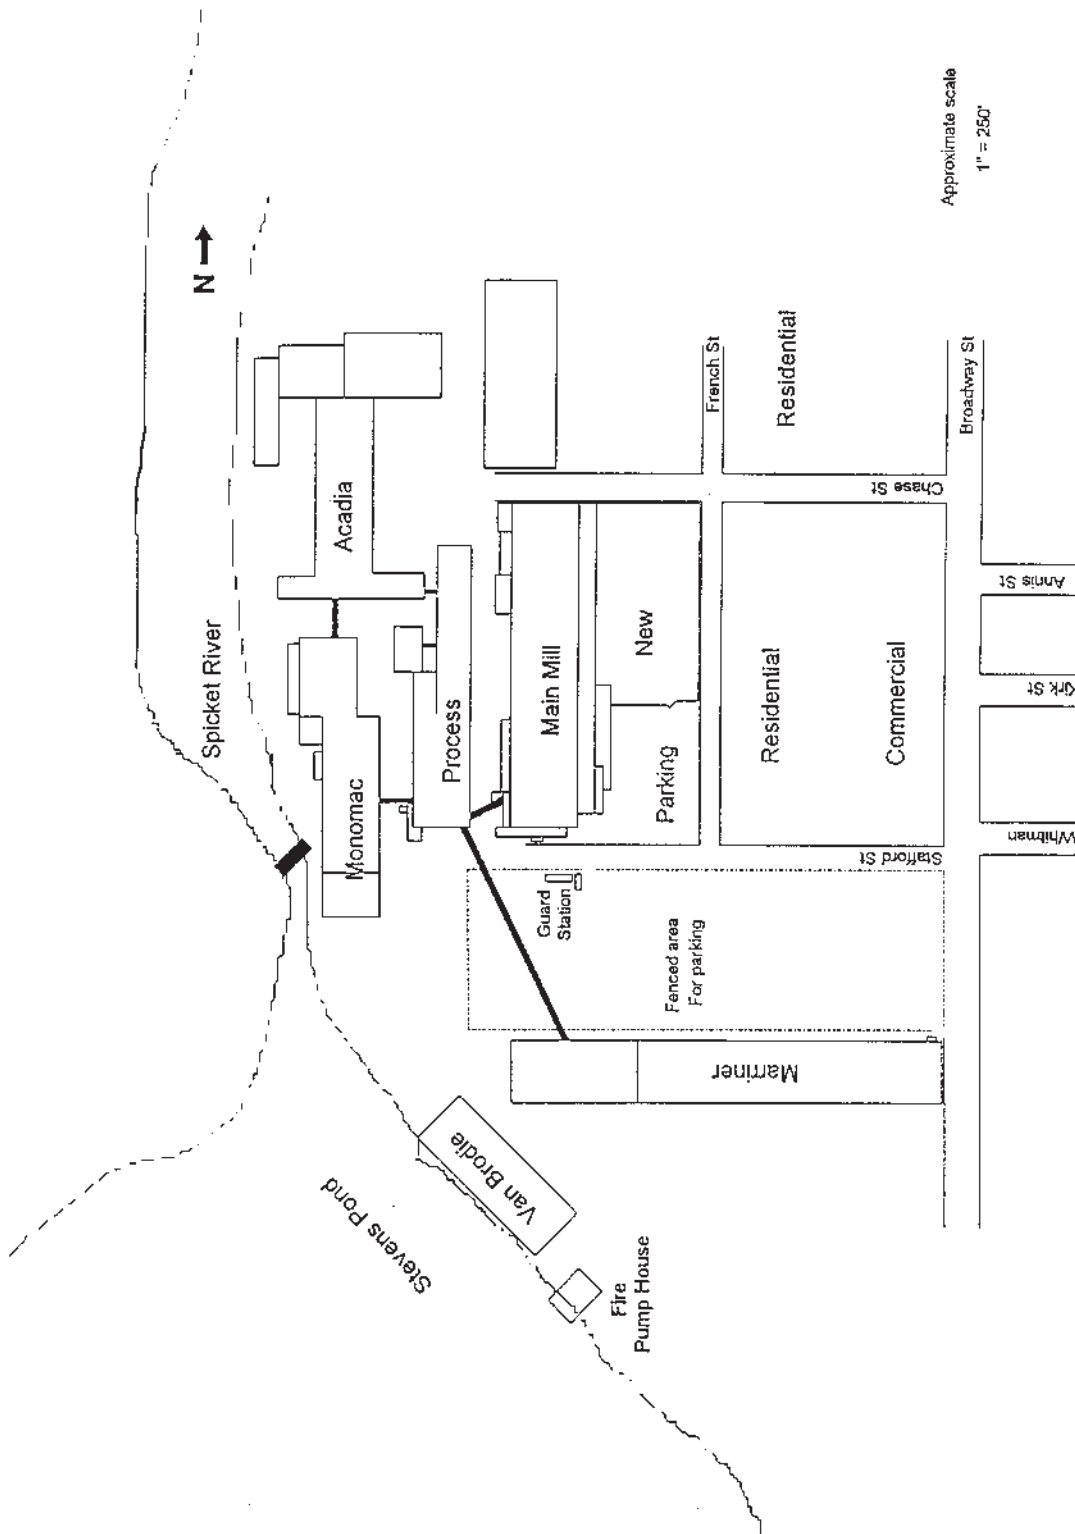
**Figure 1**  
Area Plan

The fire originated in the Monomac building, which was approximately 500 ft. long, 100 ft. wide and 5 stories (approximately 100 ft.) high. The Acadia Mills building, which was about 360x100 ft. in area and three stories (60 ft.) in height was located about 50 ft. north of the Monomac Building. These two large buildings ran north and south, parallel to the Spickett River, and were connected by an enclosed overhead passageway at the third floor level. (Figure 1).

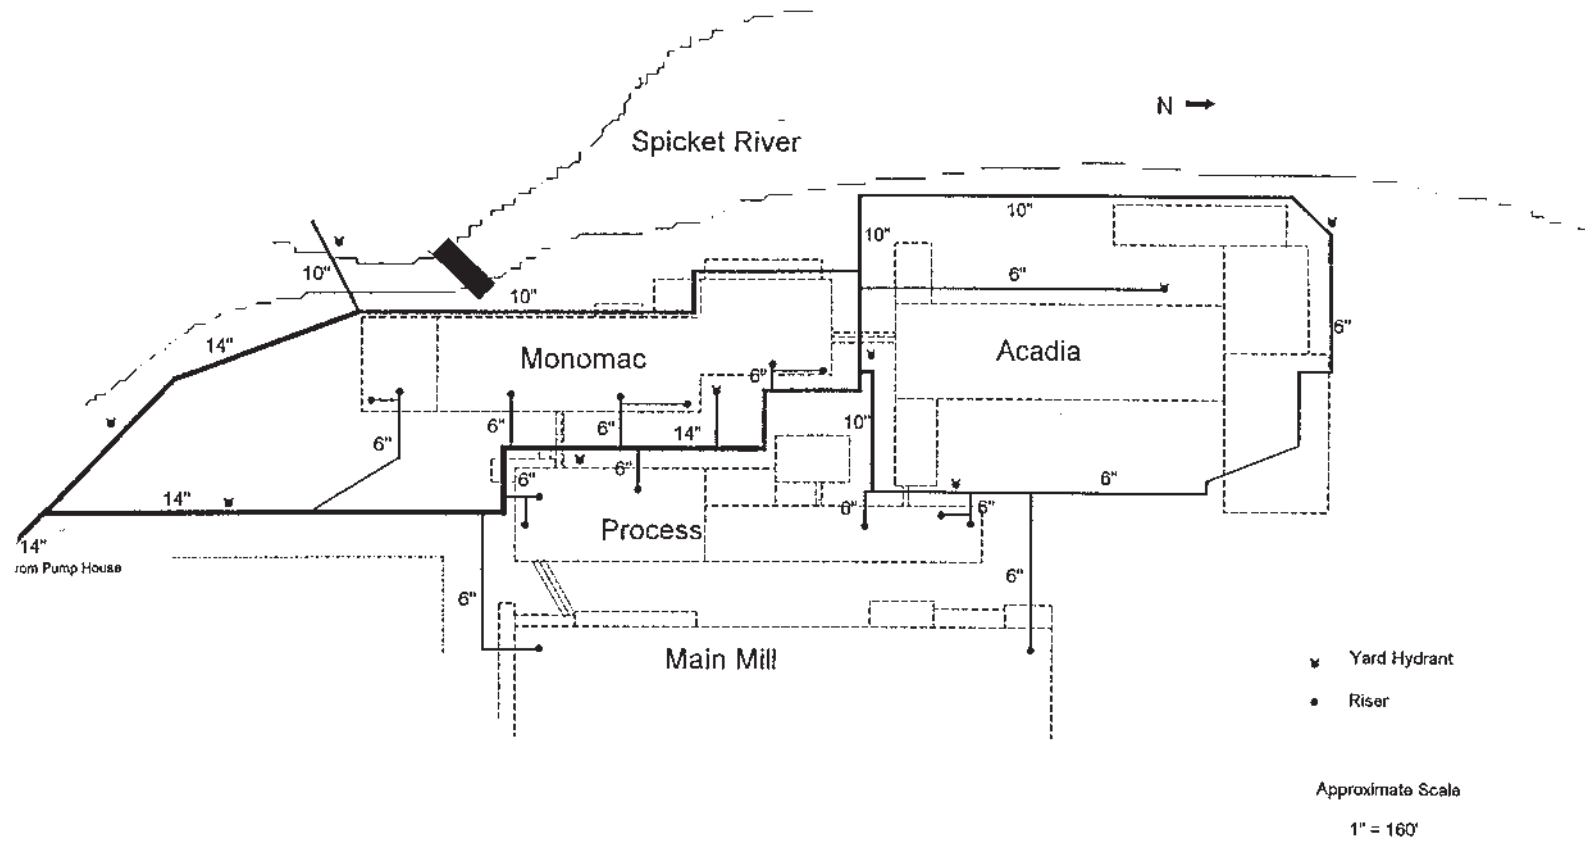
**Figure 3**  
Private Water System

The on-site fire protection system was supplied by a 2000 gpm electric fire pump and a 2000 gpm diesel powered backup pump which both drew water from the river. Both pumps could operate simultaneously to supply a rated capacity of 4000 gallons per minute to the fire protection systems. A 750 gpm jockey pump was set to maintain a static pressure of 120 psi in this system. A 14" main delivered water from the pump house to the alley between the Monomac and Process buildings. A 10" main was buried to the west of the Monomac and Acadia buildings, parallel to the river, and the loop was completed by a 6" main. (Figure 3)

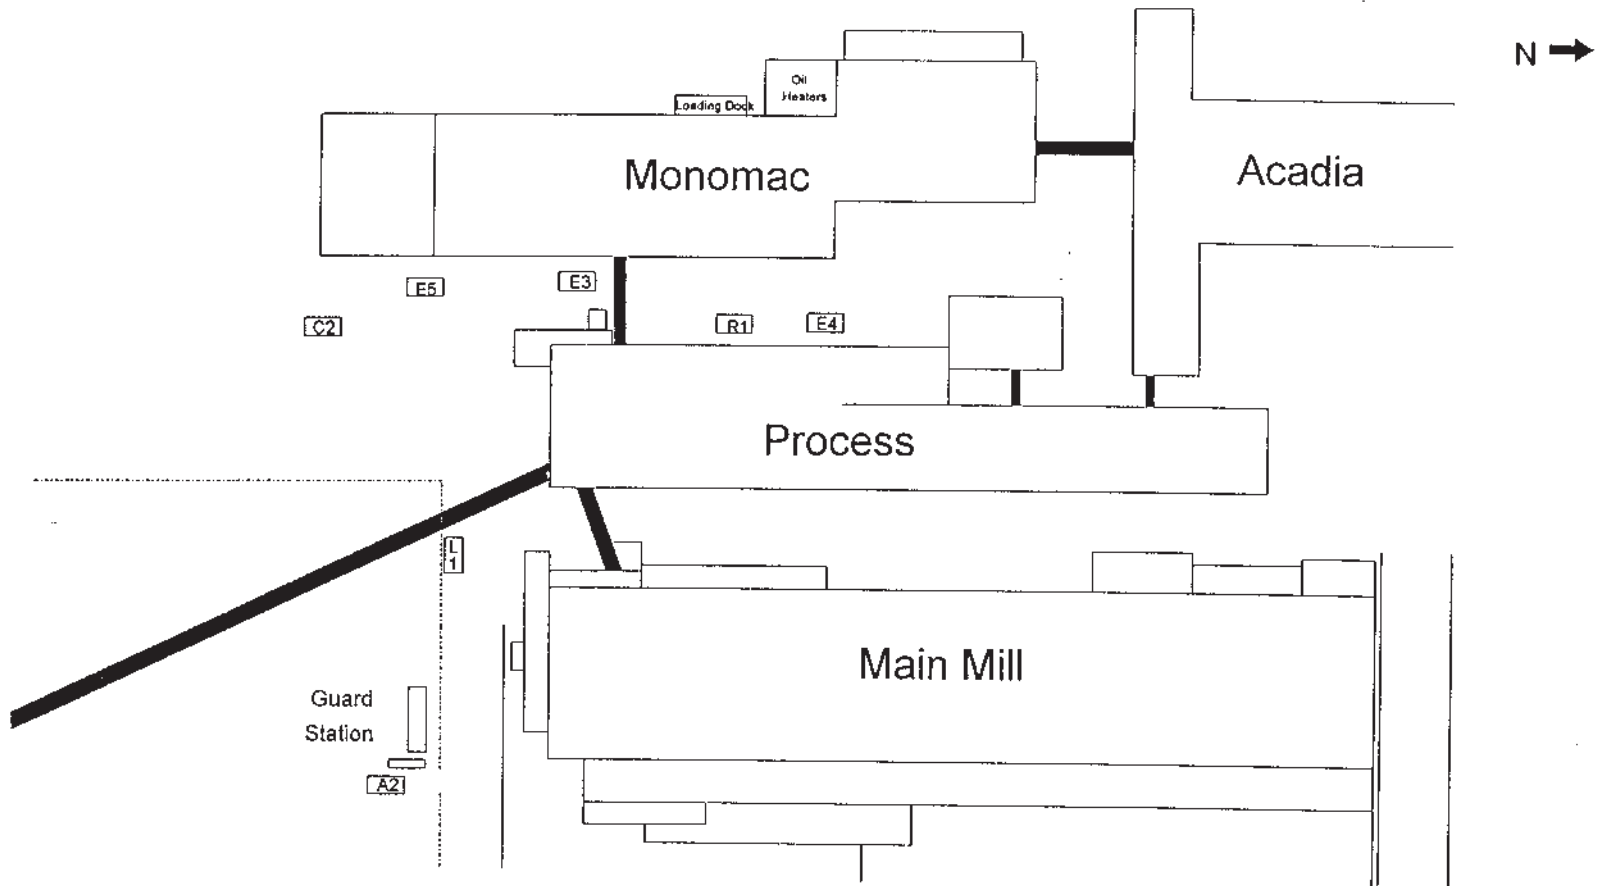
**Figure 5**  
Placement of Initial Response for Search and Rescue

Arriving on the scene at about 8:08 p.m., the Deputy Chief was told that workers were still trapped in the Monomac Building. Engine 4 and Rescue 1 were assigned to initiate search and rescue and, as they followed a guard to the alley between the Monomac and Process Buildings (Figure 5), they encountered several burned workers who were being assisted toward the guard station. Arriving at the scene, Ambulance 2 set up a multi-casualty incident (MCI) command post at the guard station and began triage.

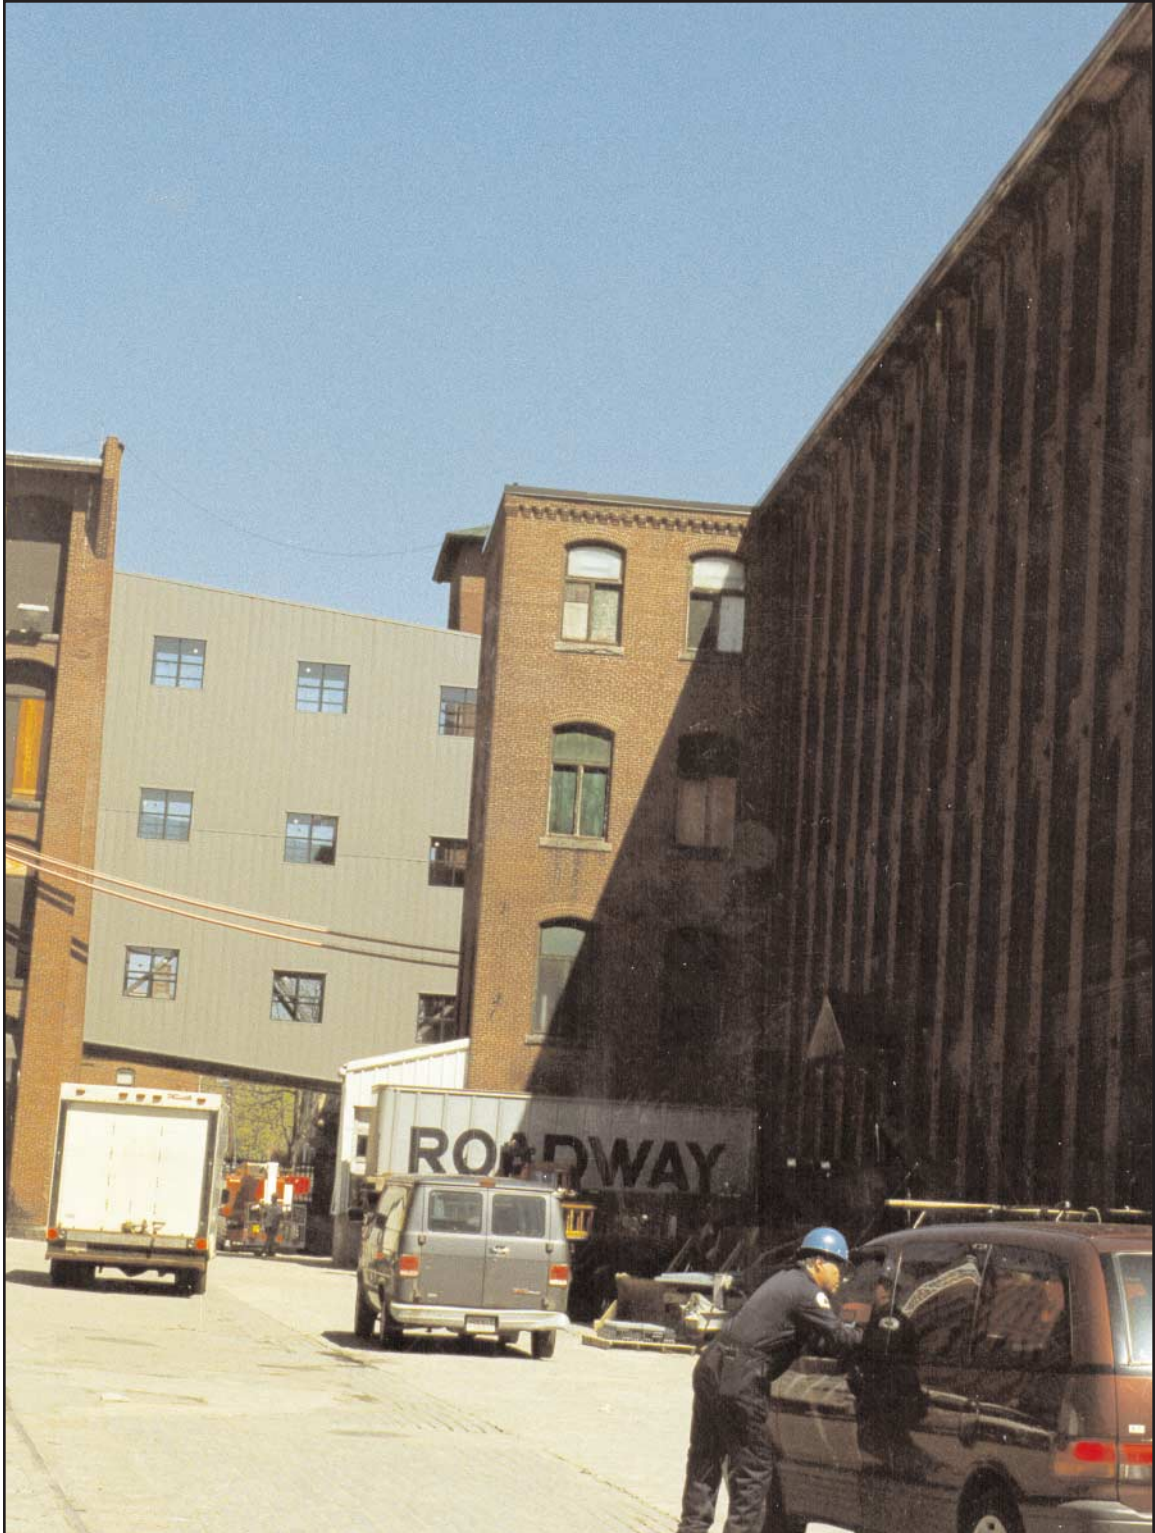
8. Example of an undamaged overhead connecting bridge in another part of the site.

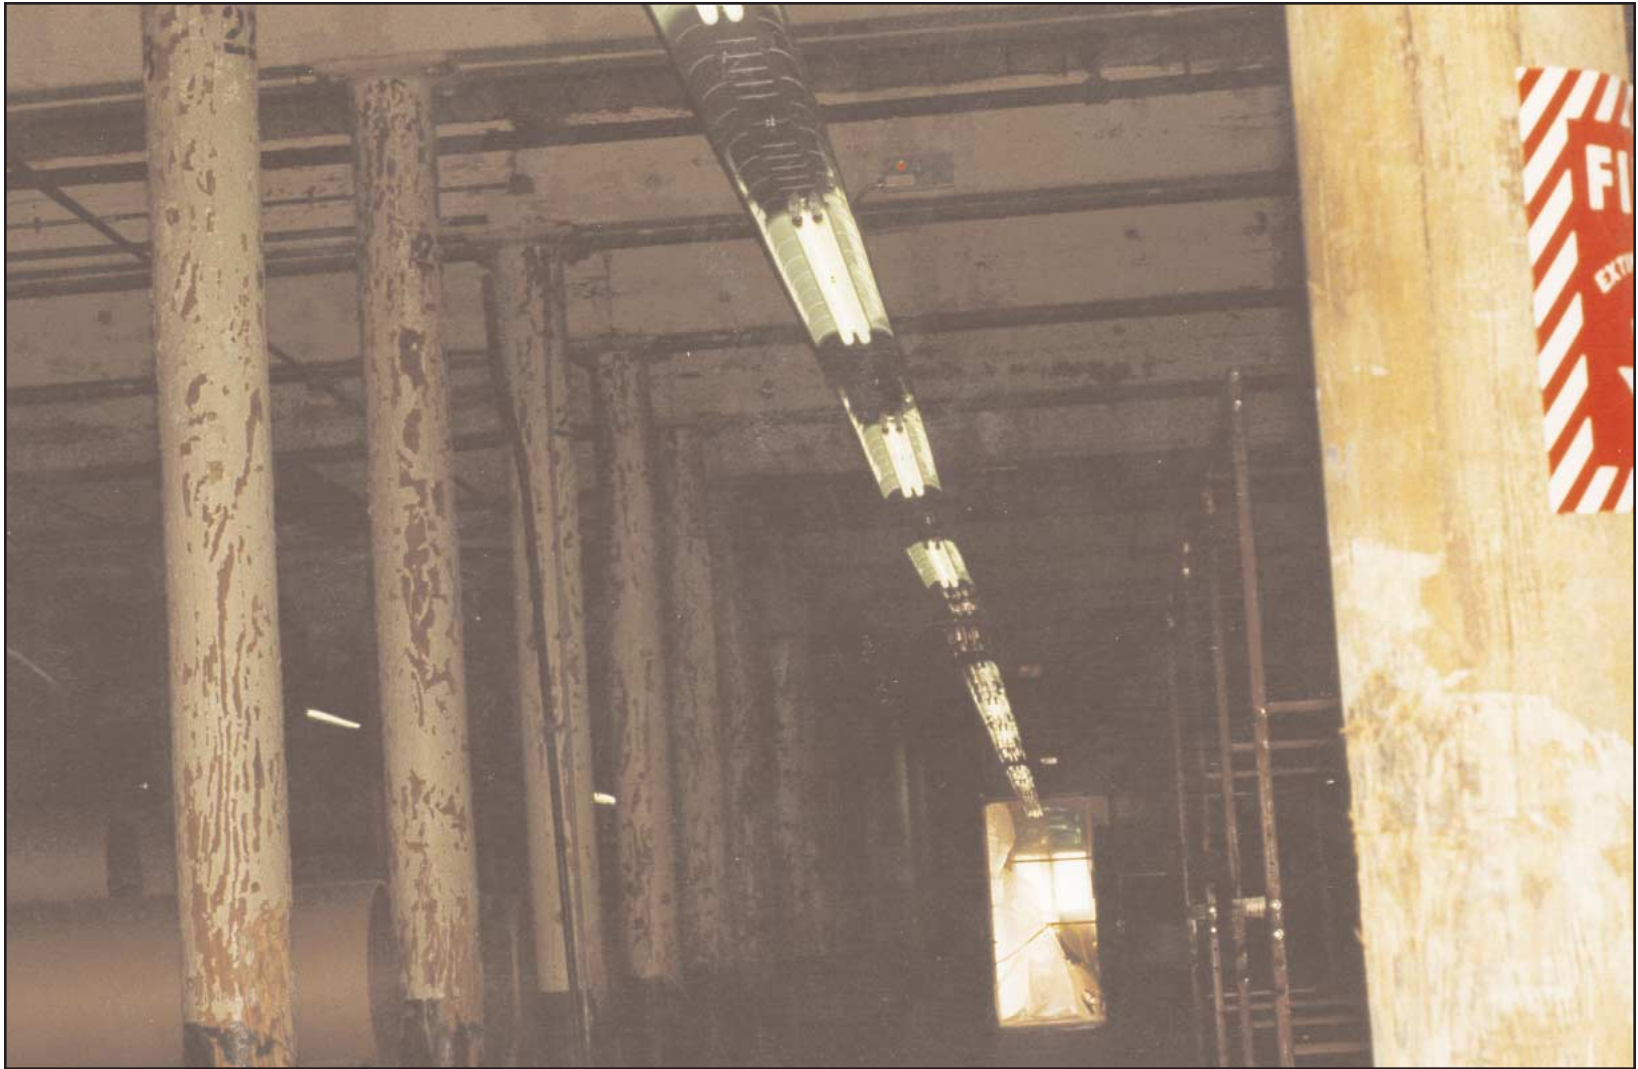
9. Typical mill building construction with heavy wood beams and thick wood floors.
